Shoreland Assessment of Shell Lake

Washburn County, Wisconsin

December 2013

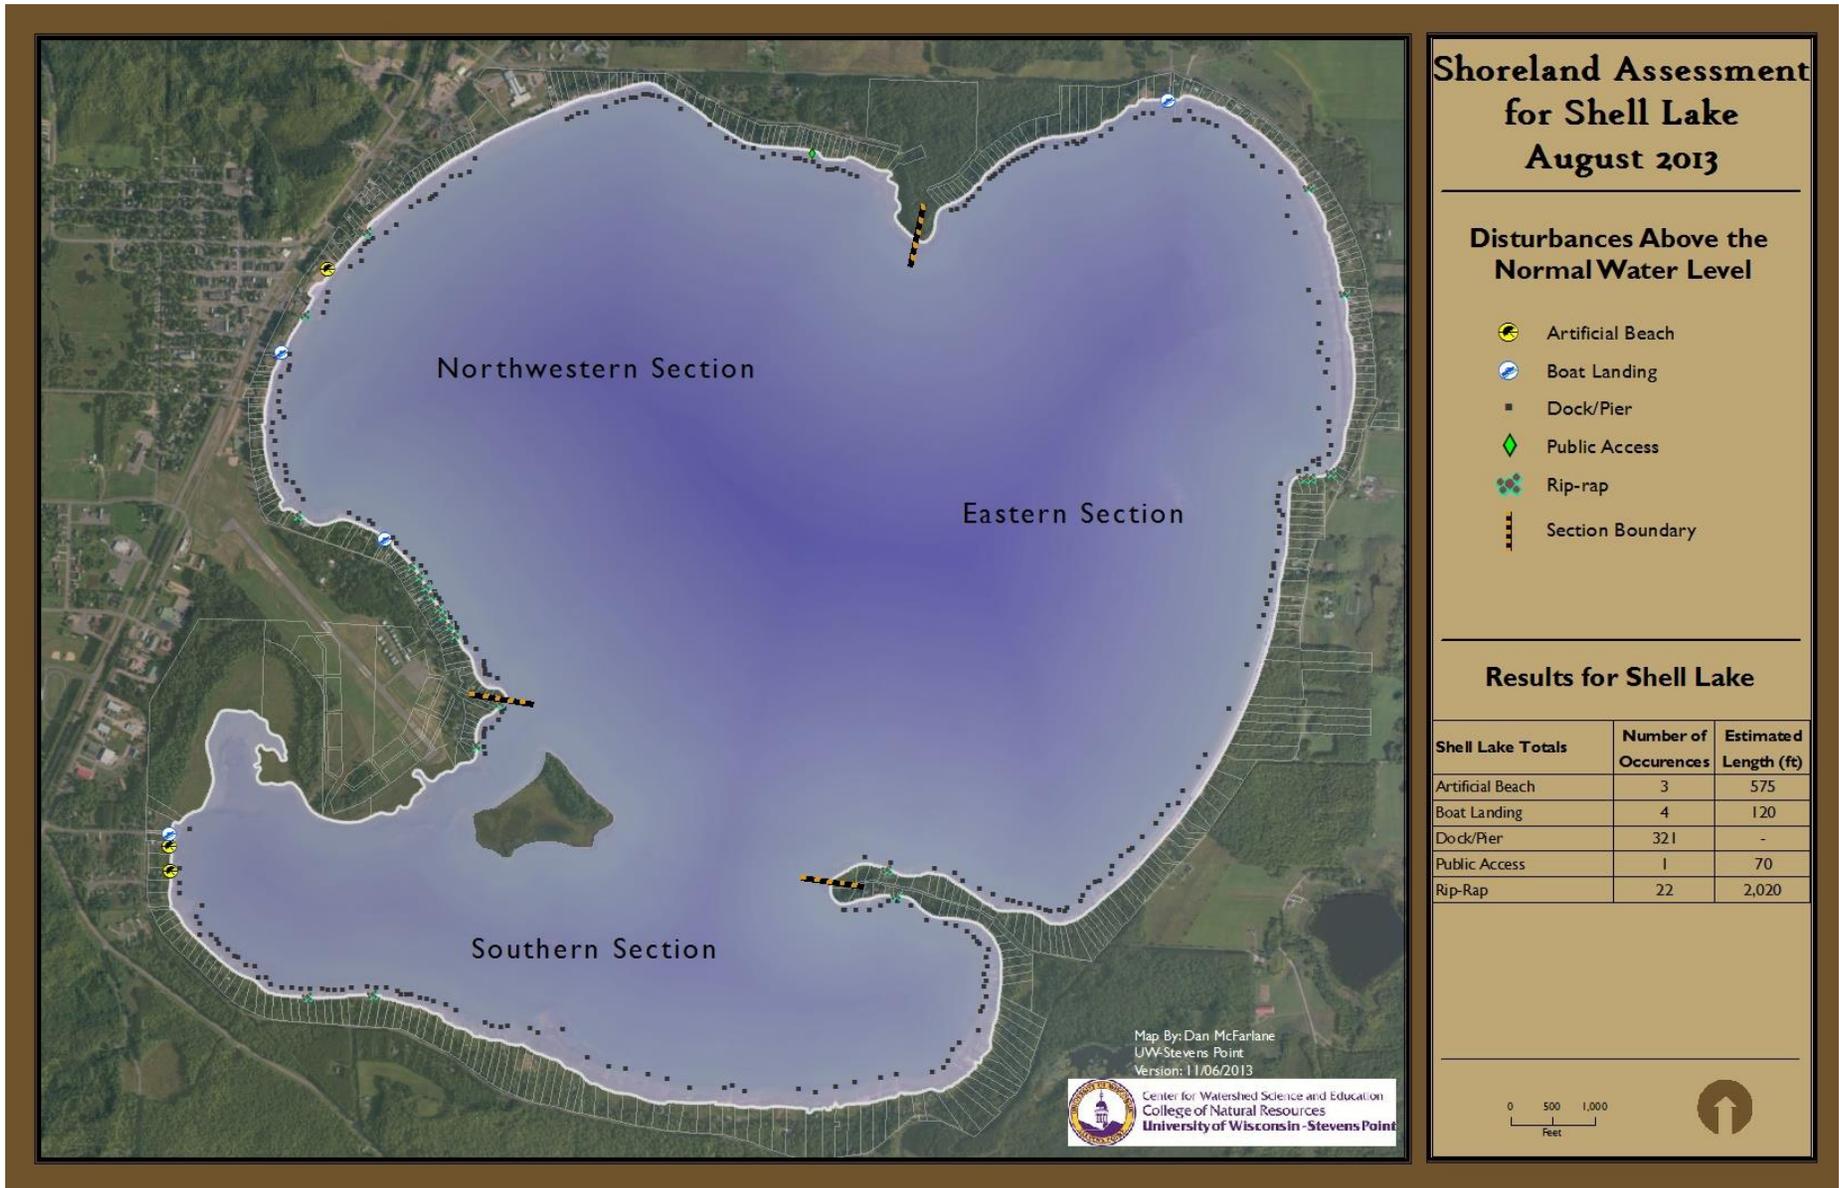
Figure 6: Shoreland disturbances above the normal water level in Shell Lake, 2013.

While docks provide access to the water and boats, they do alter to the shoreland by breaking up habitat. Shell Lake had 321 docks during this survey (Figure 6).

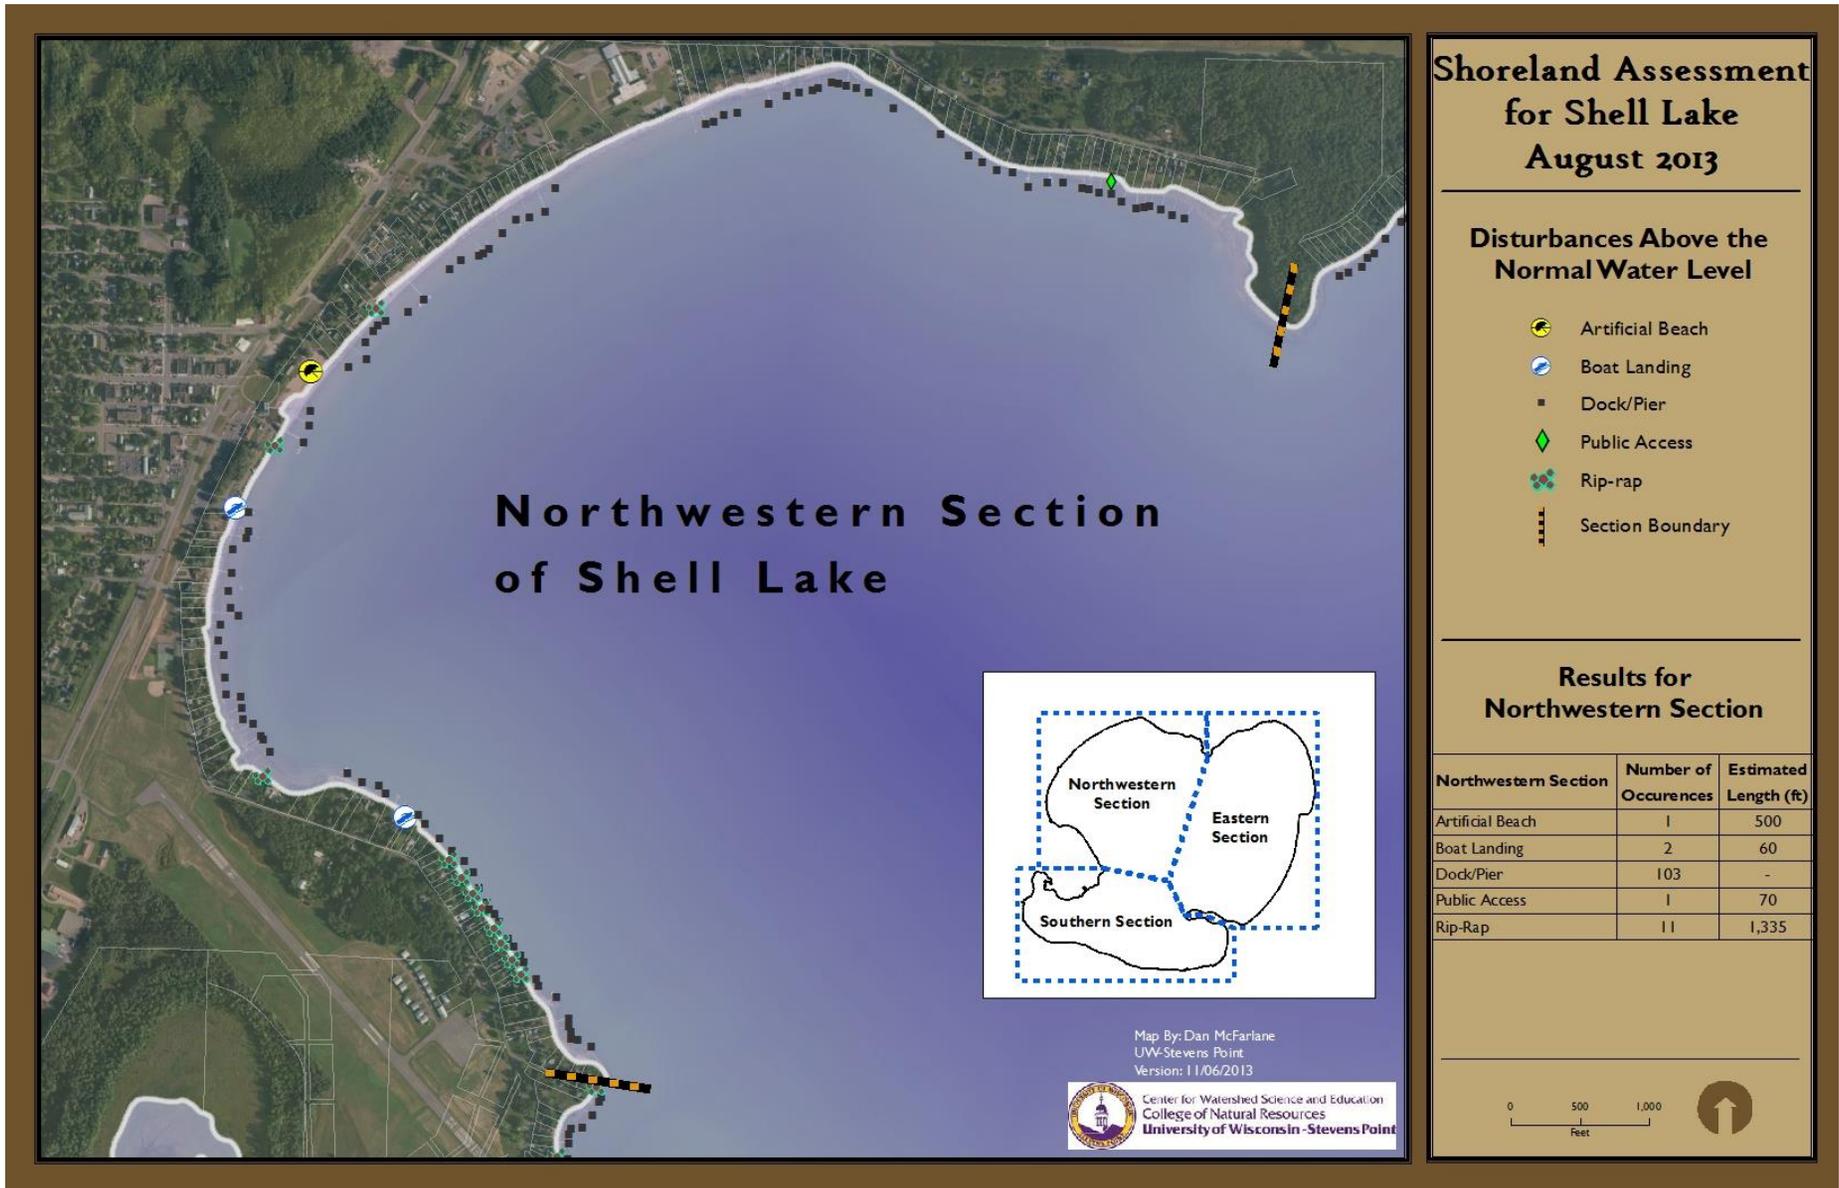
Figure 7: Shoreland disturbances above the normal water level in Shell Lake for the northwestern section, 2013.

This section of the lake was host to the majority of the shoreland disturbance. The 11 rip-rap locations account for an estimated length of 1,335 feet of the shoreline in this section. Nine of the 11 rip-rap locations are concentrated adjacent to each other in the southwestern portion of this section (Figure 7). This is a large stretch with little shoreland habitat and no healthy shoreland vegetation. Whenever possible rip-rap should be removed and replaced with properly engineered shorelines where native shoreland vegetation can be reestablished. One artificial beach exists in the Northwestern section of Shell Lake, and its estimated length is 500 feet. This beach is located near the campgrounds, one of the two boat landings, and between two rip-rap locations. Beach activity contributes to sediment supply to the lake, but is largely unavoidable if the beach is to remain present. Attempts may be made to break up the beach by planting trees or adding terraces.

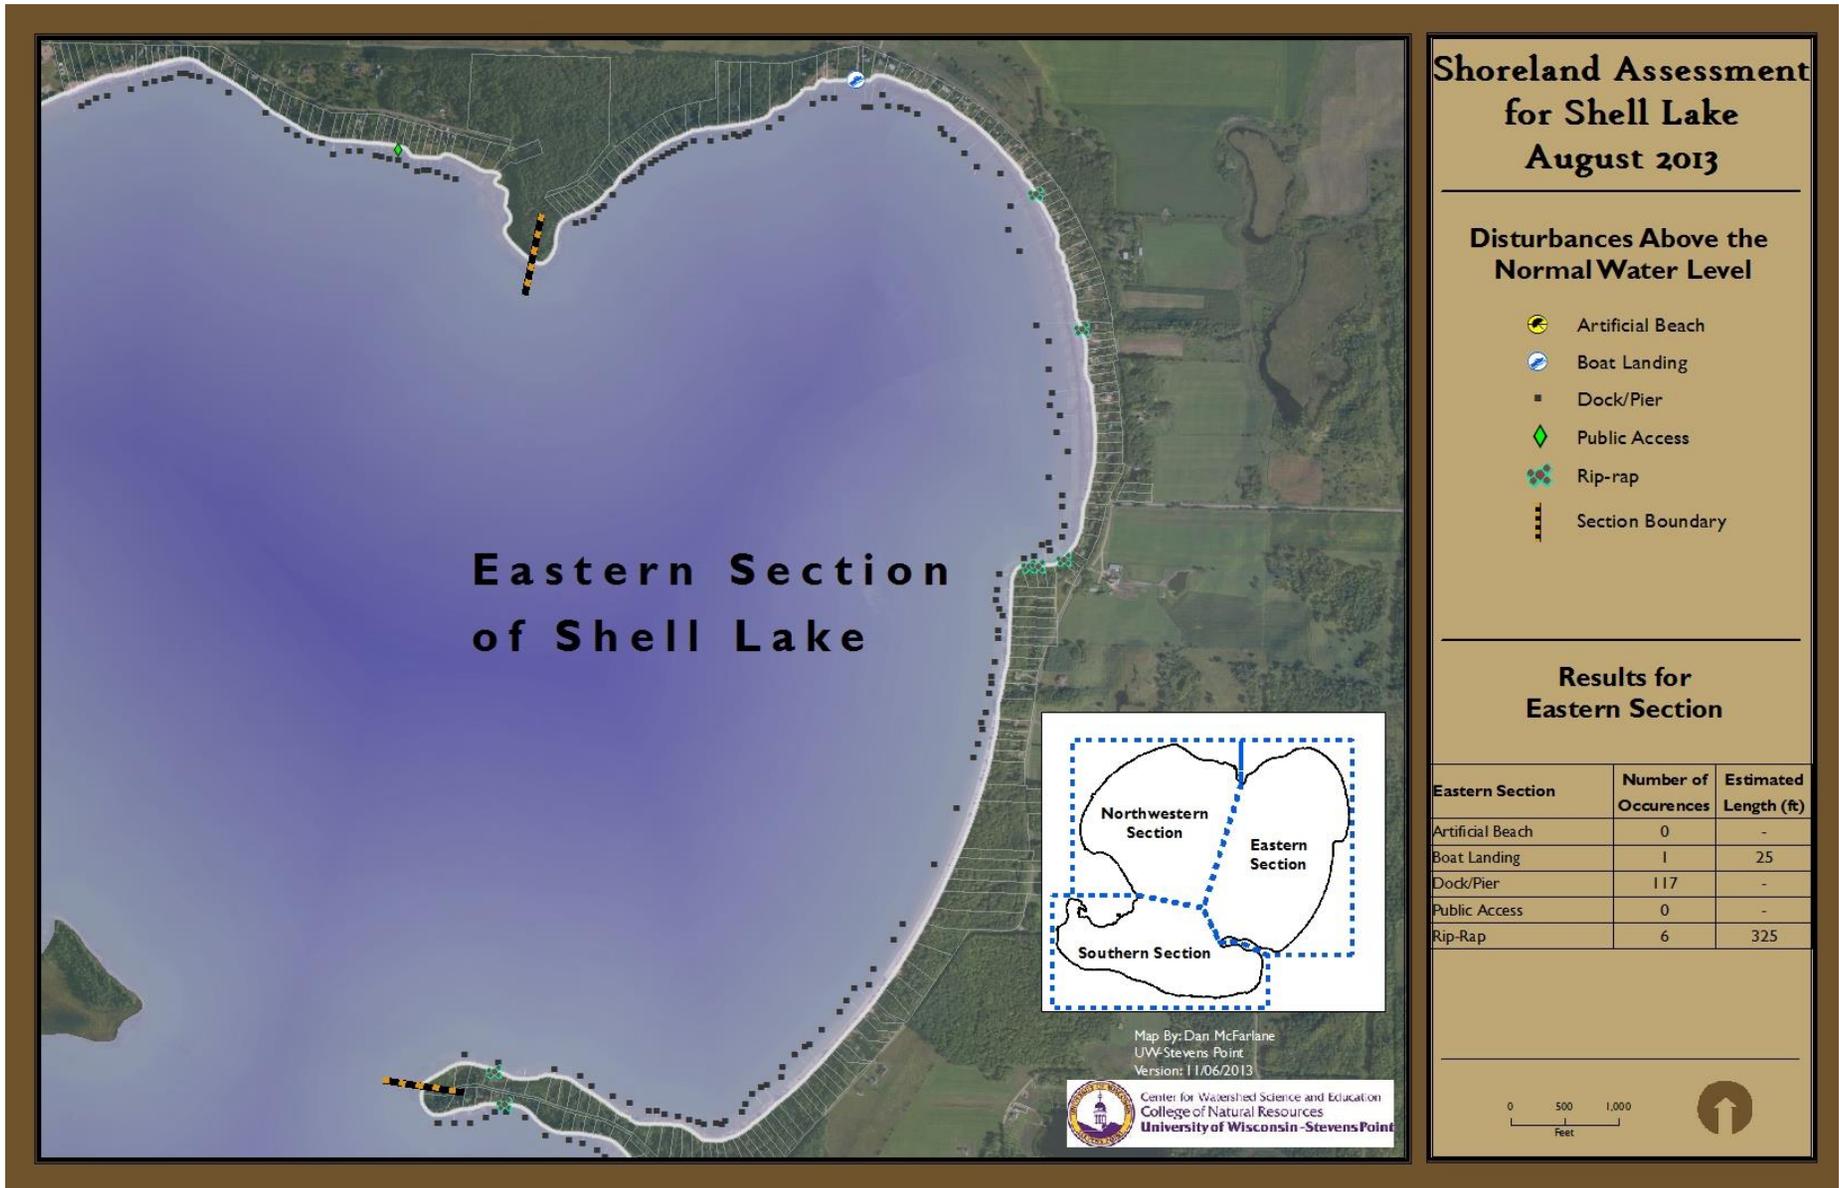
Figure 8: Shoreland disturbances above the normal water level in Shell Lake for the eastern section, 2013.

Most of the disturbance in the eastern section was docks, which totaled 117 (Figure 8). There were six areas with rip-rap with an estimated length of 325 feet.

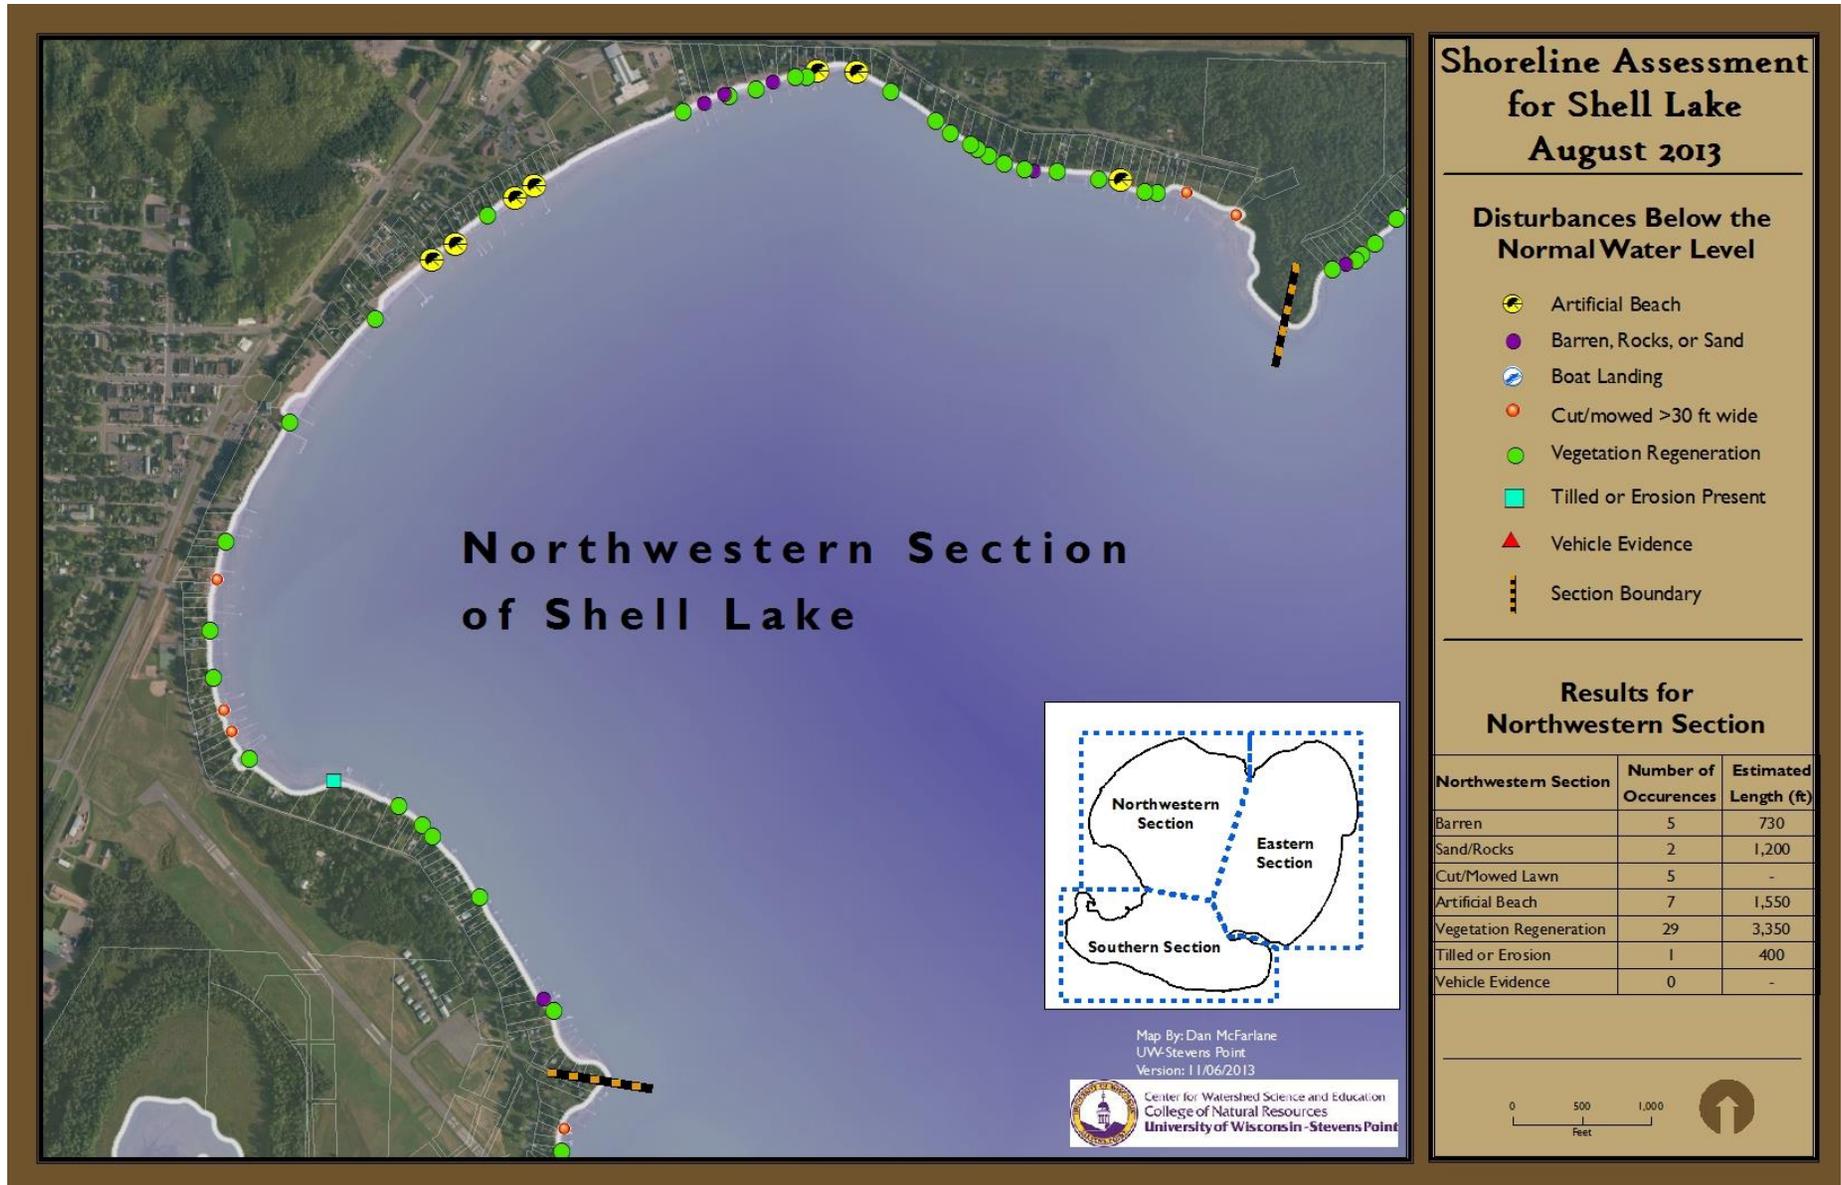
Figure 11: Near shore disturbances above the below water level in Shell Lake for the northwestern section, 2013.

The northwestern section had a significant amount of vegetation regeneration occupying its shoreline. There were 29 total restoration occurrences with an estimated length of 3,350 feet. As these locations continue to resemble the shoreline's natural state they will provide suitable habitat for fish and other wildlife when lake levels increase. Sand and rock comprised two which accounted for 1,200 feet of the shoreline. There were seven occurrences of artificial beaches with an estimated length of 1,550 feet of shoreline (Figure 11).

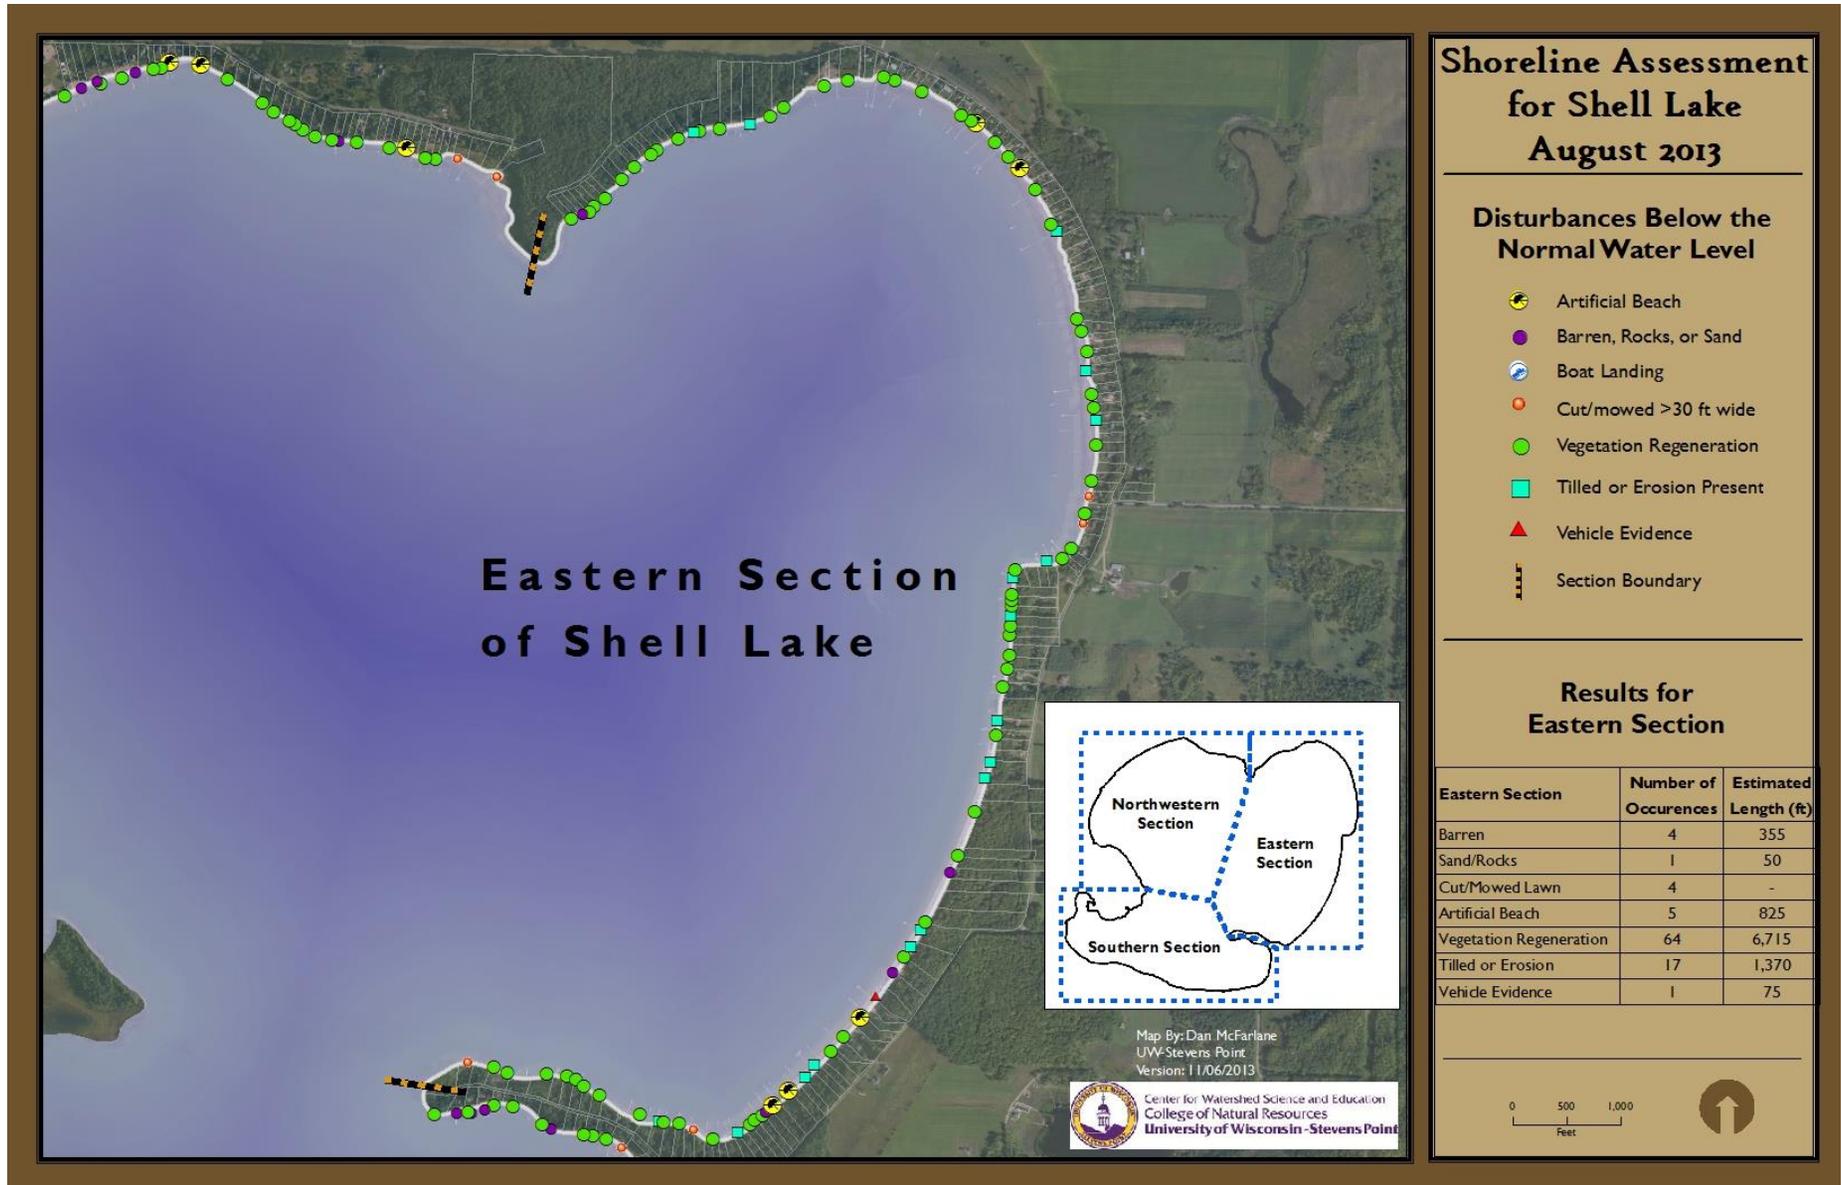
Figure 12: Near shore disturbances above the below water level in Shell Lake for the eastern section, 2013.

The eastern section had a significant amount of regeneration on its shoreline. There were 64 sites with an estimated length of 6,715 feet (Figure 12). Seventeen sites were tilled and/or had erosion in this section, comprising an estimated length of 1,370 feet. Tilling the substrate prevents these fragile habitats from returning to their natural state. Likewise, areas of erosion make it difficult for natural vegetation to grow, and contributes increased movement of sediment to the lake. There was one instance of vehicle use, with a total estimated length of 75 feet in this section. Vehicles operation on the exposed lakebed disturbs natural vegetation that is attempting to regrow.

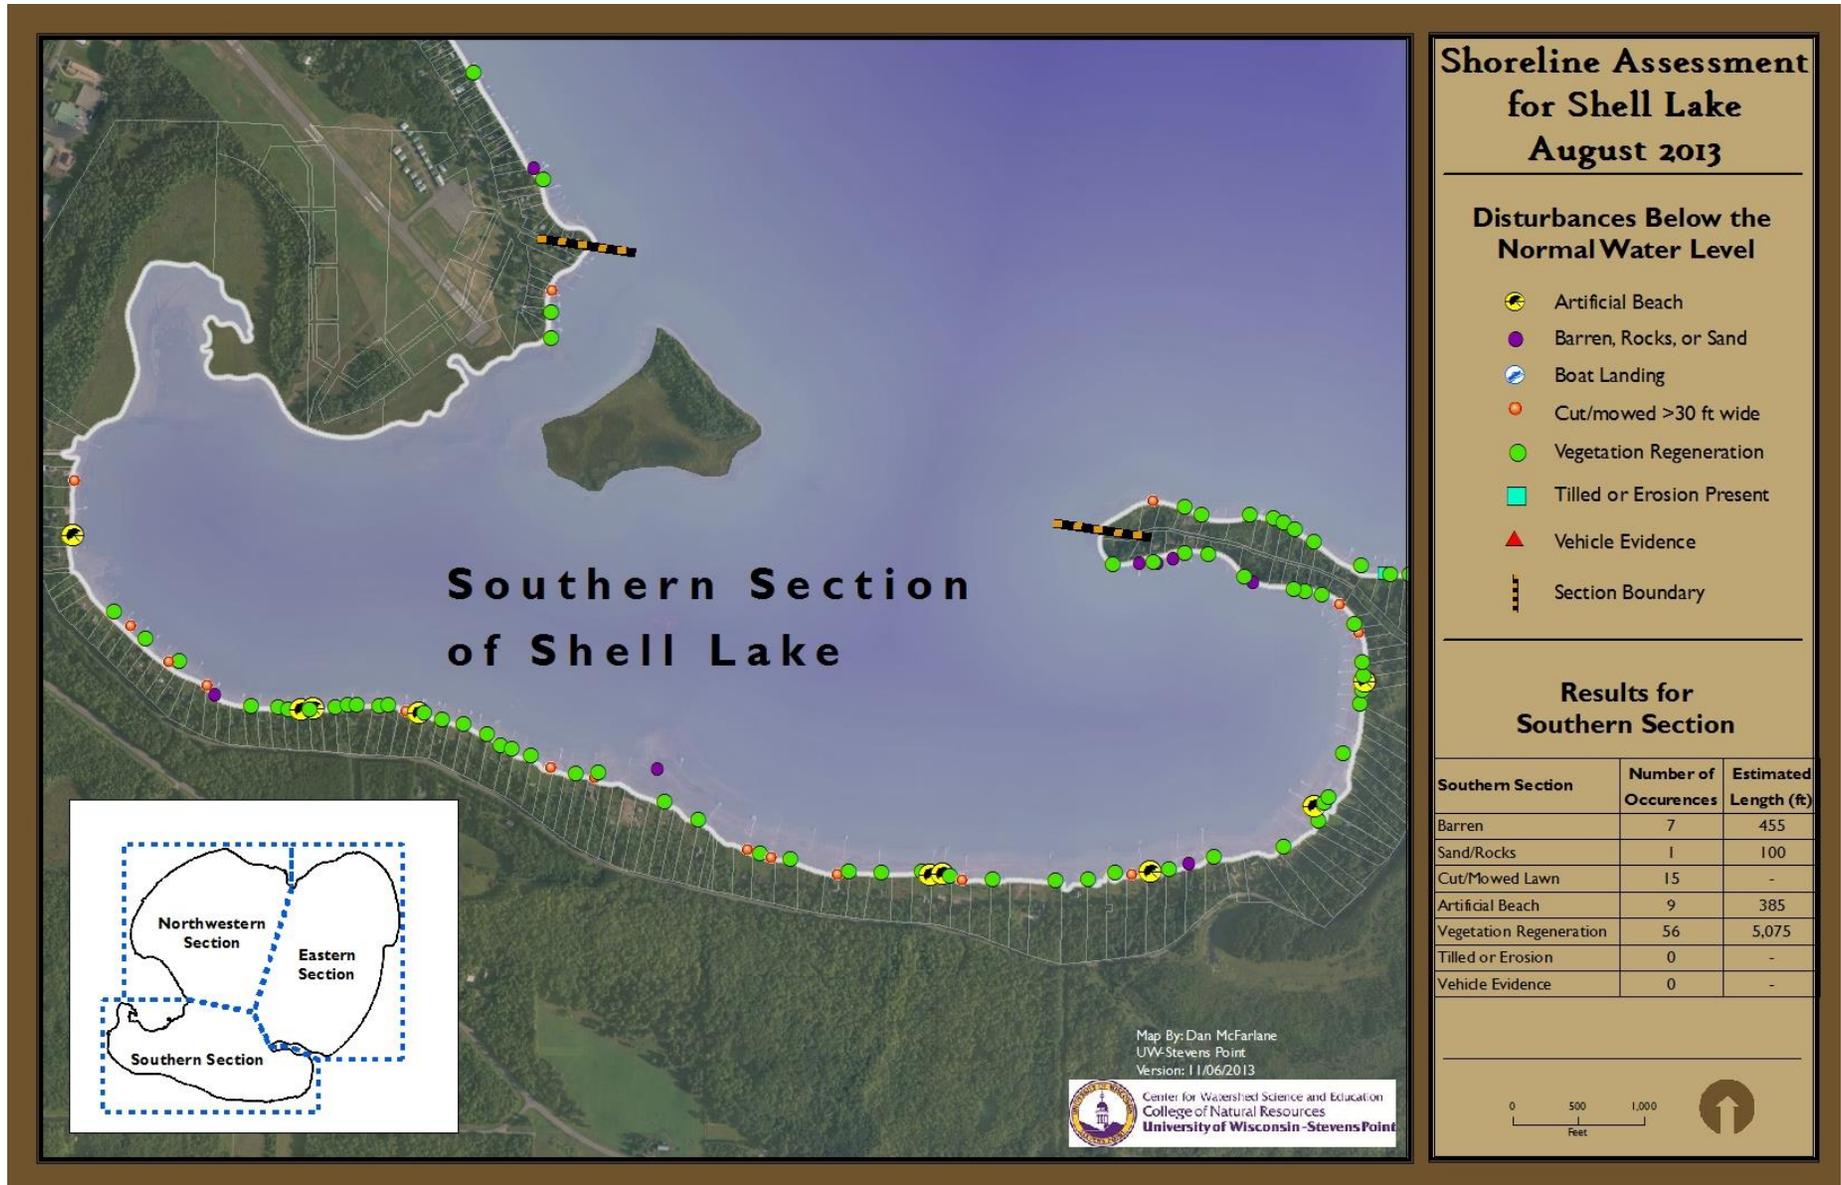
Figure 13: Near shore disturbances above the below water level in Shell Lake for the southern section, 2013.

The southern section had 56 sites with regeneration totaling an estimated length of 5,075 feet (Figure 13). No evidence of vehicle use, tilled areas of erosion was identified in this section. This section had fifteen occurrences with lawns mowed to the water's edge. During the periods of low water, this activity increases runoff to the lake and eliminates shoreland habitat and when the lake levels increase the shallow water will lack habitat for fish and other aquatic animals.
