# Citizen Assessment of Critical Habitats & Priority Shorelines 2010

Grindstone Lake, Sawyer County, Wisconsin

Document prepared by Douglas Miskowiak, GIS Education Specialist  
Maps prepared by Jon Galloy and Mike Broton, GIS Student Interns  
University of Wisconsin-Stevens Point, GIS Center

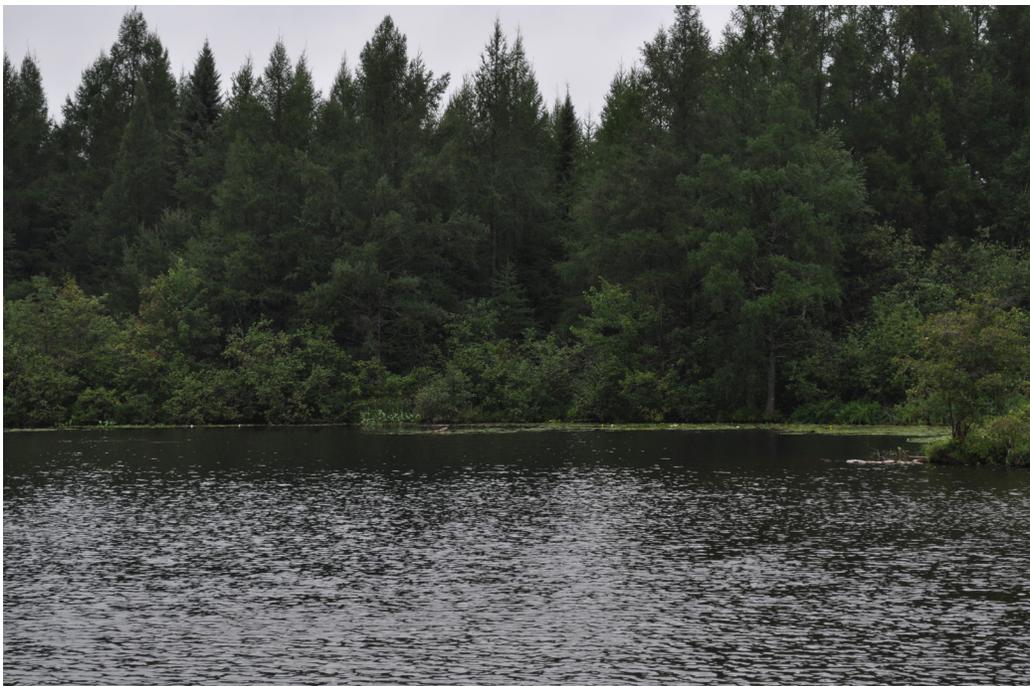
**Figure 4.4.1**

This tamarack bog, an ecologically valuable landscape, is displayed as woody wetlands on the land cover map from 2001. This landscape has likely existed in a similar condition since the pre-settlement surveys of the middle 1800's.

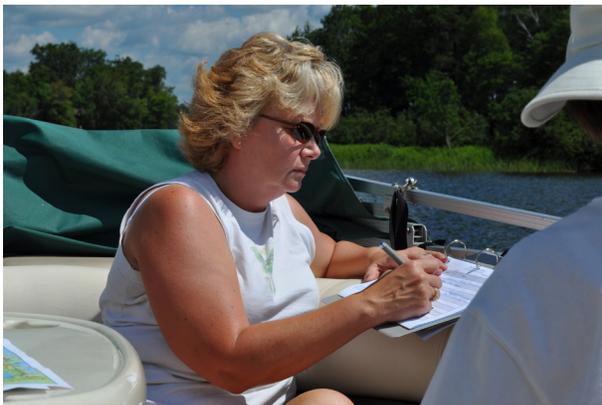
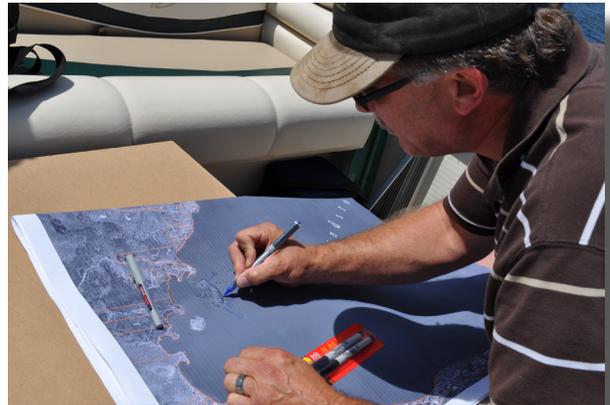
**Figures 5.0.2 and 5.0.3.**

A team of citizens worked together to document shoreline characteristics. For each stretch of shoreline one or more citizens would document the characteristic and record it in a log book with an identification number. A second team of citizens would record the same stretch of shoreline on a hardcopy map and tag it with the corresponding identification number.

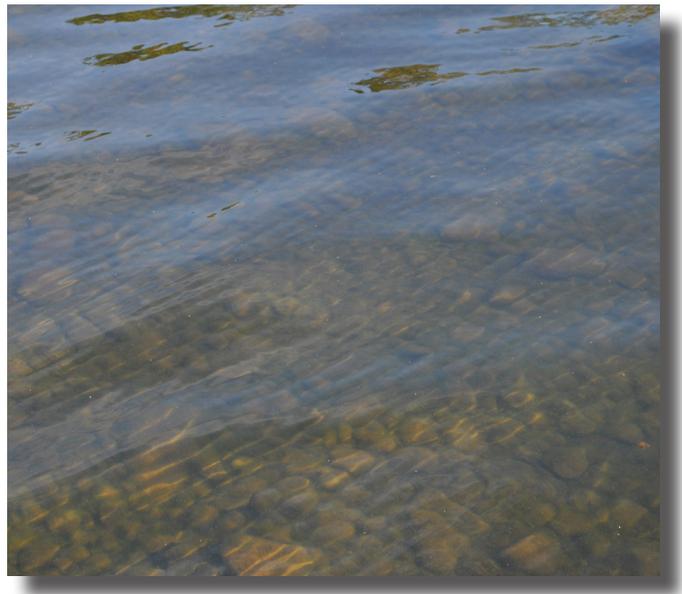
This photograph displays shoreline bottom consisting predominantly of rubble/cobble mixed with some gravels. This substrate is suitable for small-mouth bass in browsing for food and walleye spawning.

Shoreline erosion, however, can fill these substrates with sediments and eliminate their benefits to the fishery.

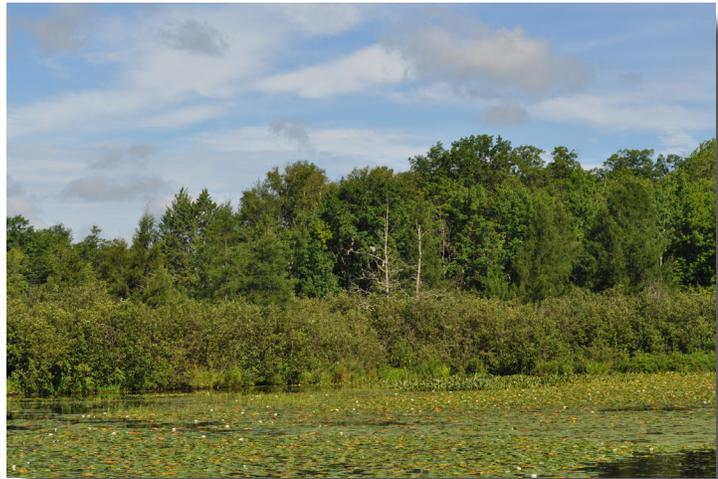
Scrub/shrub wetlands, depicted here, provide valuable ecosystem services that benefit both wildlife and humans.

Wetlands help keep the waters of Grindstone Lake clean of sediments and other pollutants.

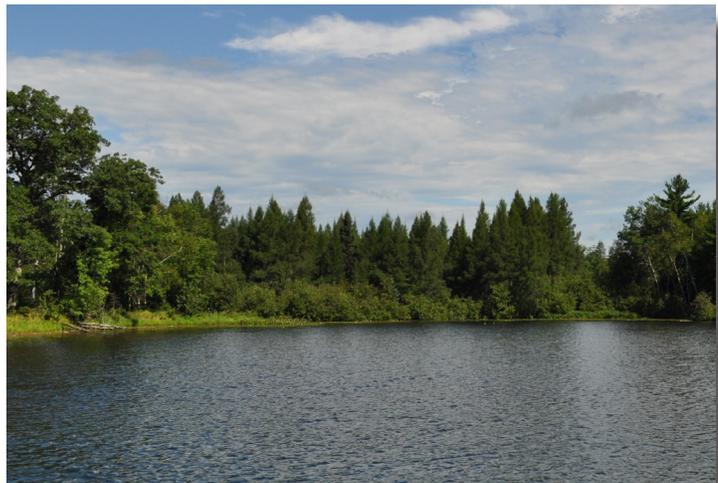
Figure 5.3.2.

The tamarack bog on Grindstone Lake, located near the lake's two islands, is a relatively rare landscape type that provides benefits for wildlife and a unique aesthetic experience.

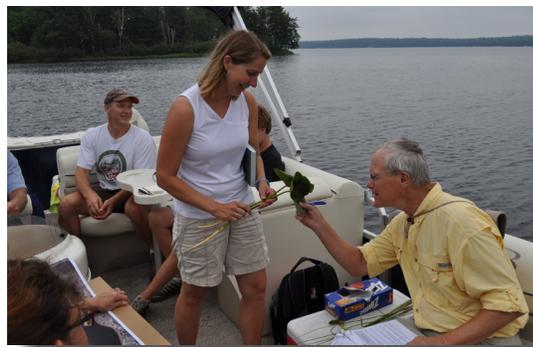
Figure 5.4.1.

Kristi Maki from the Sawyer County Land and Water Conservation Department helps citizens learn how to identify different species of emergent and floating leaf aquatic macrophytes.

Macrophytes are leaves that can be seen without assistance from a magnifying device.

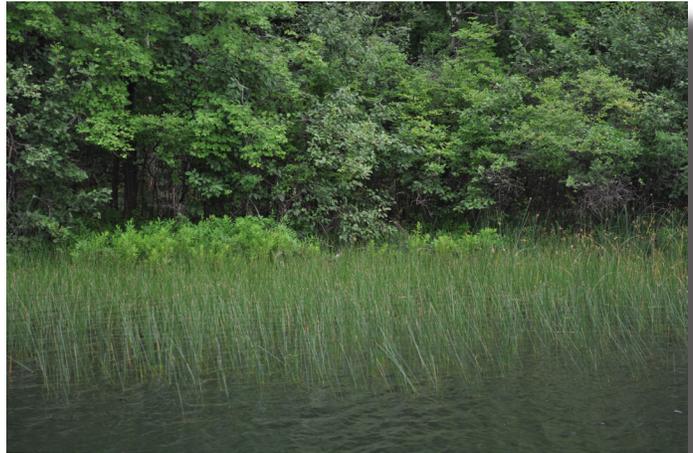
Figure 5.4.2.

This bed of rushes helps to control shoreline erosion by calming wave action and collecting sediments.

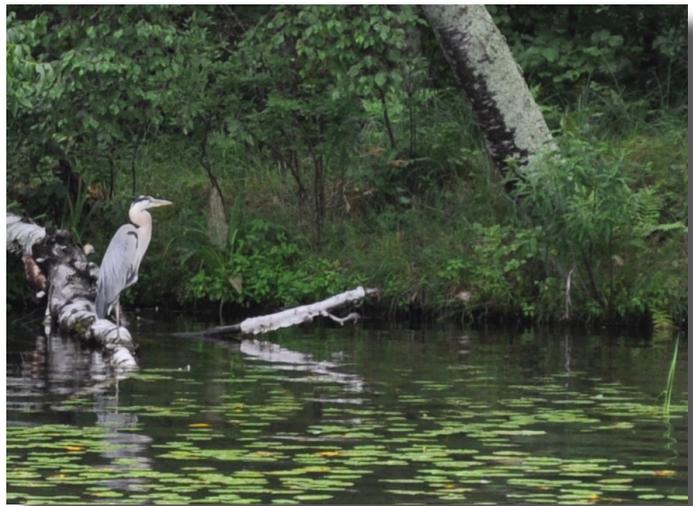
Figure 5.4.3.

A great blue heron takes advantage of the floating leaf aquatic macrophytes in search of its next meal.

Floating leaf macrophytes also are beneficial to minimize shoreline erosion from wave action.

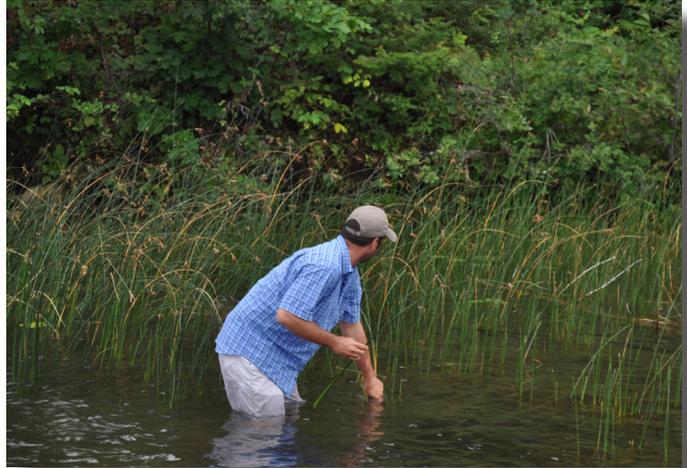
Figure 5.4.4.

Jon Galloy gets a closer look at an emergent aquatic before citizens document the type of aquatic macrophyte in the inventory.

Here citizens were trying to distinguish between sedges and rushes. Rushes are round while sedges have edges.

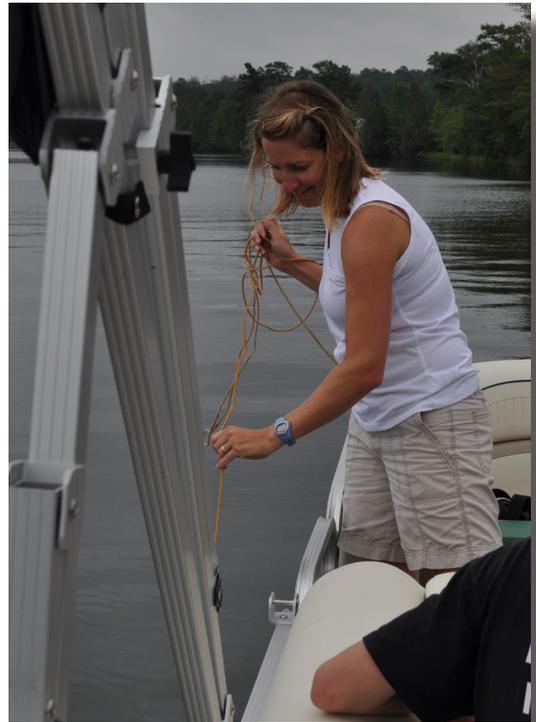
Figure 5.4.5.

Kristi Maki searches for submerged aquatic macrophytes by dragging a rake along the bottom of Grindstone Lake.

Submergent aquatic macrophytes were not inventoried in this lake plan.

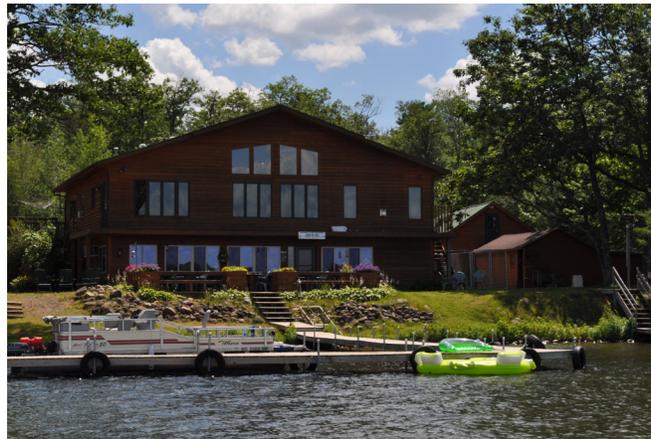
Removal of riparian vegetation compromises water quality and the fishery on Grindstone Lake by allowing additional sediments and other pollutants into the system.

Aesthetically, this structure inhibits the publics' right to enjoy the natural scenic beauty of navigable waters as protected by the Wisconsin Constitution and the Wisconsin Public Trust Doctrine.

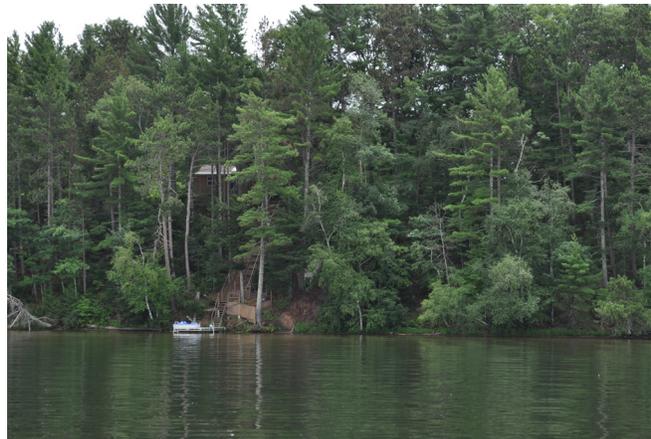
Figure 5.6.2.

An example of development that does a good job of protecting the riparian vegetation.

Natural riparian vegetation slows sediments and pollutants from reaching the water.

Natural vegetation also protects the publics' right to the natural scenic beauty of Wisconsin's Public Trust Waters.

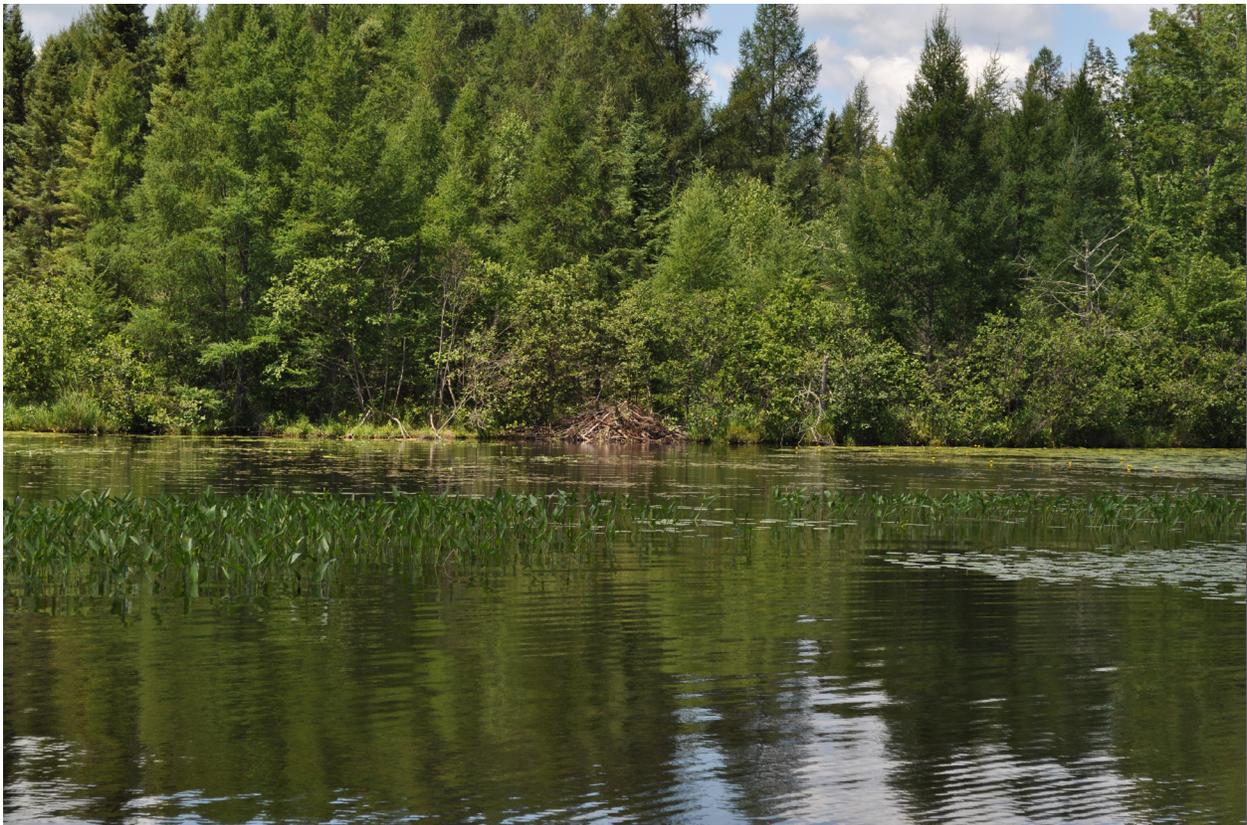
The western shores of Grindstone Lake, behind the islands, harbor the largest concentrations of various priority features. This photo shows several of them, including: riparian wetlands, aquatic macrophytes, tamarack, coarse woody habitat, and in a naturally scenic condition.
