CAMPUS PHYSICAL DEVELOPMENT PLAN

2019-21 Capital Budget

University of Wisconsin Stevens Point
April 2018

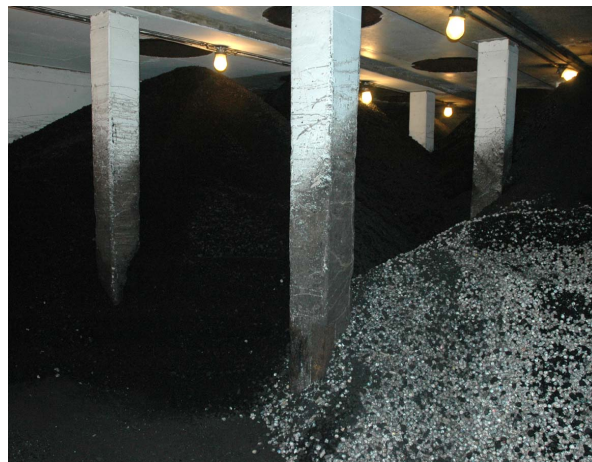
The coal bucket elevator (right) is slowly and surely wearing out. The plant engineer and superintendent have suggested that expected functional life is approximately two years.

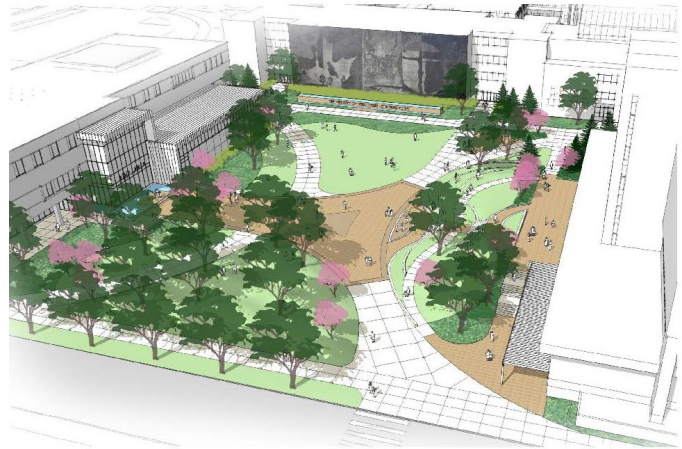
The 2007 Master Plan identified various areas around campus for updates and improvements and also provided guidelines for development. A primary focal point for redevelopment was the Specht Forum “Sundial” in the center of the academic core. Concept plans have since been developed by the national landscape architectural firm. The plan will add shade trees, sitting areas, a central plaza, performance and art display platforms, a central plaza, an intuitive pedestrian crossing pattern, lawn space, areas for sculpture, educational landscape species, an outdoor café, and water features. These elements will be installed while still protecting views of the iconic ceramic tile mural “E. Pluribus Unum” on the south side of the Trainer Natural Resources building. A more responsive handicapped ramp access to the Learning Resources Center (LRC) main floor will be provided along with a direct at-grade entrance to the LRC lower level. The current Forum is in poor repair and concrete needs replacement. A phased approach to the reconstruction is a possibility through a combination of future renovations of nearby buildings or could be completed if a significant gift to campus is made.

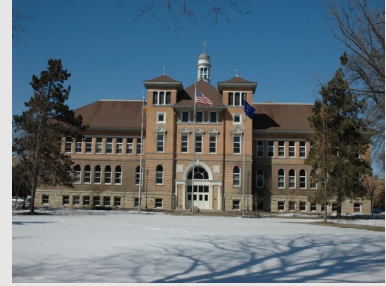
B	FUNCTIONAL RATING	PHYSICAL RATING	iii
<i>Building Profile ratings based on the Postsecondary Education Facilities Inventory and Classification Manual (FICM): 2006 Edition</i>

The building is structurally sound but its HVAC system is antiquated and in need of replacement.

Exterior of the building needs cleaning; entrance doors leak-frames need replacement. A major HVAC and air distribution project is required.

The interior foundation of the two-wall system, most prevalent on the south, is disintegrating and is in need of proper wall cavity drainage. Exterior façade is stained and needs to be cleaned. Chimney brick needs tuckpointing and replacement. Other exterior tuckpointing is acceptable.

Some roof leaks and problems with icicles forming. Exterior doors have rusted frames. Interior concrete steps are deteriorating. Windows are energy inefficient.

HVAC system inefficient and difficult to control (few VAV's, no reheat and inoperative inlet vortex dampers on fans). Pneumatic controls are limited, inefficient and panels (and associated plumbing) are unlabeled / poorly configured (resemble spaghetti). HVAC zones are confusing, poorly configured and difficult to operate. Air handlers are extremely old and no longer dynamically balanced (very loud, significant vibration). Coils (heating & cooling) have reached their useful life and require frequent leak repair. Many shutoff valves are frozen and leak when exercised. Fiber ductwork throughout the building is failing (fracturing at seams). Chilled water coils are undersized and cannot maintain 55 degree discharge temperature. Restroom exhaust is unable to meet demand. Perimeter heating system is incapable of maintaining consistent temperatures.

Sanitary lines are clay and have experienced root problems necessitating replacement.

Elevator is over 32 years old and is included in All Agency request for replacement.

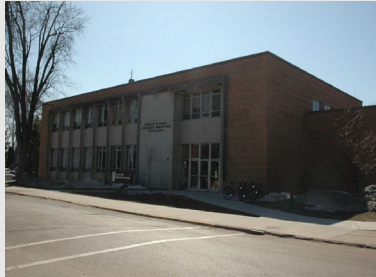
Building Name	Park Student Services Center

Building No.	285-OK-0002						
Building Type	B01 Administrative						
Constructed Addition(s)	1952			Floors	AG 2	UG 1	
ASF	30,478	GSF	51,181	GPR	100 %	PR	0 %
CENTRAL UTILITY CONNECTIONS				HISTORICAL			
CW	<input checked="" type="checkbox"/>	ELEC	<input checked="" type="checkbox"/>	C. AIR	<input type="checkbox"/>	US	<input type="checkbox"/>
HPS	<input checked="" type="checkbox"/>	FIBER	<input checked="" type="checkbox"/>	N. GAS	<input type="checkbox"/>	WI	<input type="checkbox"/>
D	FUNCTIONAL RATING				PHYSICAL RATING		iv
<small>Building Profile ratings based on the Postsecondary Education Facilities Inventory and Classification Manual (FICM): 2006 Edition</small>

Master Plan recommends demolition.

Original steam convection & distribution pipes (condensate pipe walls thinned / deteriorated beyond suitable repair). Difficult temperature control (few VAV's, few reheat coils and few t-stats). Pneumatic controls are limited, inefficient, integrate poorly to DDC, repair parts are difficult to obtain and zones are poorly configured. Earlier renovations left long, looping, inefficient runs of flexible ductwork. No ducted air distribution in former book stack areas.

No back-up generation to operate HVAC fans/actuation, outages in winter could result in freeze-up due to inability to circulate steam heat. Main distribution panel board, poor condition. Breaker panels, limited capacity

Rest rooms fixtures and piping, poor condition. Domestic hot water heater is old and leaking. Controls are no longer available.

Elevator, poor condition, inappropriate location and undersized.

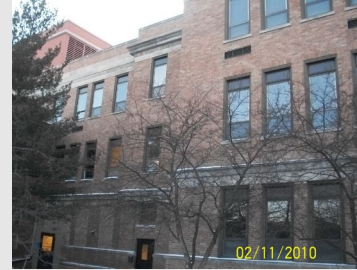
B	FUNCTIONAL RATING	PHYSICAL RATING	iv
<i>Building Profile ratings based on the Postsecondary Education Facilities Inventory and Classification Manual (FICM): 2006 Edition</i>

Building has an accessible entrance at the northeast corner entering into the back of the building – accessibility should be at primary entrance. Entrance stonework badly broken.

Stairs do not meet current building code. Stairs do not have fire-rated doors and glazing. Handrail extension and guard rail height is non-compliant. Stair which was added to the old gymnasium space is non-compliant because stair shaft terminates into the vestibule area and not directly to exterior. Floor tile is deteriorating; some due to settling. Main entrance does not have architectural integrity with the type and age of the facility, broken stone at main entrance both unsightly and unsafe. Parapet wall on west side is leaning.

No back-up generation to operate HVAC fans/actuation. Emergency generator is old and parts are difficult to obtain. Outages in winter could result in freeze-up due to inability to circulate steam heat. Main distribution panel board, poor condition. Breaker panels, limited capacity. Existing emergency distribution system is not segregated properly for NEC 700, 701 and 702 loads. Area does not meet codes with properly segregated loads.

Elevator currently has a 2,000-pound capacity with a 4'X6' cab. As an existing elevator, the interior elevator cab dimensions meet the current ADA code, study needed to verify that the controls meet ADA code. Included in All Agency request to replace.

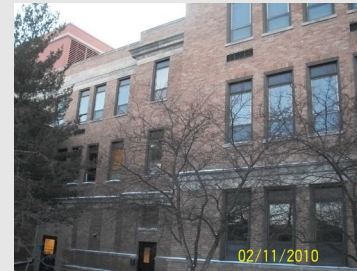
B	FUNCTIONAL RATING	PHYSICAL RATING	iv
<i>Building Profile ratings based on the Postsecondary Education Facilities Inventory and Classification Manual (FICM): 2006 Edition</i>

Access Control system compromised, building needs to be totally re-keyed or ideally, replaced with electronic locks.

Main distribution panel board, poor condition. Breaker panels, limited capacity. Existing emergency distribution system is not segregated properly for NEC 700, 701 and 702 loads. During renovation, area to be brought up to code with properly segregated loads. With full building renovation replace generator.

Elevator currently has a 2,000-pound capacity with a 4'X6' cab. As an existing elevator, the interior elevator cab dimensions meet the current ADA code, study needed to verify that the controls meet ADA code. Included in All Agency request to replace.

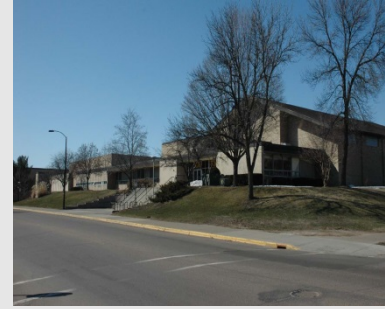
B	FUNCTIONAL RATING	PHYSICAL RATING	iii
<i>Building Profile ratings based on the Postsecondary Education Facilities Inventory and Classification Manual (FICM): 2006 Edition</i>

Office space remains inadequate for staffing needs. Racquetball court could be repurposed. New women’s locker room was constructed but lockers were not installed.

Energy consumption for heating and ventilating continue to rise with the ever increasing traffic through the North/South corridor between Residential Living and the Academic core. Scoreboards in MAC and swimming pool need replacement.

Undersized non-ADA compliant elevator should be replaced. A conversion of space above the training and equipment rooms is needed to provide for a Wellness Assessment Lab. Purchase and install equipment to create a K-12 Physical Education lab out of a former dance studio is needed.

Challenging ADA path of travel for some areas of the building. Hard key access control system is compromised, requires electronic access control to restore acceptable building security. Provide fall protection tie downs for roof maintenance. Has one elevator in good condition in a poor location and the car is non-ADA compliant. Wood bleachers in aquatic center are deteriorating and unsafe. Quandt and Berg bleachers are deteriorating and unsafe.

Glazing-leaking windows on entire South side of building. Door frames at the top of the stairs, gymnasium entrance,

are degrading and oxidizing at their base due to salt corrosion and weather. Quandt floor is failing. Locker room size inadequate for athletic programs.

Entryway heaters are improperly sized and are ineffective at tempering entryway air. The Quandt has nine (9) small ceiling fans that are not capable of moving enough air for the area served (not enough throw distance to effectively reach the occupants). Customer complaints prevent campus from using the Quandt for large spectator events (commencement temps exceeded 90 degrees Fahrenheit) when outside temperatures exceed 70 degrees Fahrenheit. The three (3) air handlers supporting Quandt are extremely loud and prevent effective AV functions. Ductwork has not been cleaned since the building was built.

No back-up generation to operate HVAC fans/actuation, outages in winter could result in freeze-up due to inability to circulate steam heat. (only gyms have back-up generation for emergency lighting). HEC is a Red Cross evacuation center. Additionally, faculty research is regularly compromised due to storm/construction related outages. Medium voltage service and distribution center is failing. Several breakers too large for adequate protection for secondary side of transformer. Fuses and breakers must be correctly sized or replaced per 2009 Arc Flash Study.

The Building Clock system is in disrepair and in need of replacement. Limited area surveillance system needs to be addressed throughout the building.

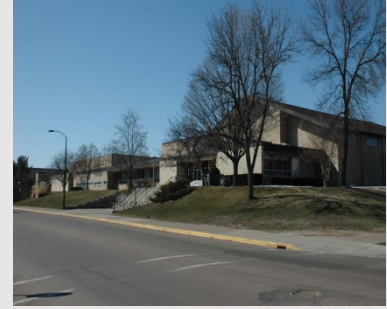
B	FUNCTIONAL RATING	PHYSICAL RATING	iii
<i>Building Profile ratings based on the Postsecondary Education Facilities Inventory and Classification Manual (FICM): 2006 Edition</i>

Office space remains inadequate for staffing needs.

ADA path of travel challenging for some portions of the building. Access control system has been compromised for more than twenty years. As a result, thefts of items in the facility remain a challenge and constant concern. Provide fall protection tie downs for roof maintenance The building has one elevator in good condition in a poor location and is non-ADA compliant

Door frames at the ground level main gymnasium entrance are degrading and oxidizing at base due to salt and weather.

The Building Clock system is in disrepair and in need of replacement. Limited area surveillance system needs to be addressed throughout the building

Bleacher systems in the Quandt Gymnasium are binding and not retracting properly. Portable bleachers require new castors due to their on-going collapse that is tearing up the floors.

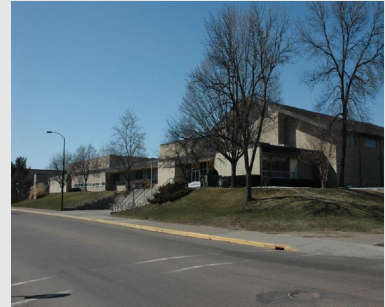
B	FUNCTIONAL RATING	PHYSICAL RATING	iii
<i>Building Profile ratings based on the Postsecondary Education Facilities Inventory and Classification Manual (FICM): 2006 Edition</i>

Due to the amount of foot traffic through the North/South corridor between Residential Living and the Academic core, the floor tile is separating, flooring showing its age. Building doors and frames are rusted and beyond repair.

Undersized non-ADA compliant elevator should be replaced. A conversion of space above the training and equipment rooms is needed to provide for a Wellness Assessment Lab. Purchase and installation of equipment to create a K-12 Physical Education lab out of a former dance studio is needed.

ADA path of travel challenging for some portions of the building. Hard key access control system is compromised, requires electronic access control to restore acceptable building security. Provide fall protection tie downs for roof maintenance. The building has one elevator in good condition in a poor location and the car is non-ADA compliant.

Door frames at the top of the stairs, gymnasium entrance, are degrading and oxidizing at their base due to salt corrosion and weather.

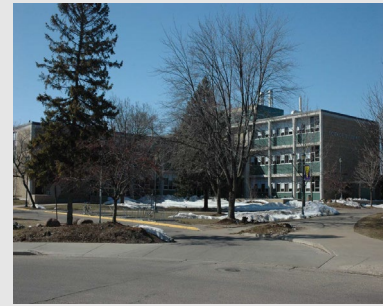
D	FUNCTIONAL RATING	PHYSICAL RATING	iv
<i>Building Profile ratings based on the Postsecondary Education Facilities Inventory and Classification Manual (FICM): 2006 Edition</i>

5-stop elevator is over 39 years old and is on the 10 Year Maintenance Replacement Plan.

Laboratory fume hoods require constant maintenance, built-in lab tables and sinks are old and unsightly. Fume hoods are for the most part at the standard height not allowing for ADA access.

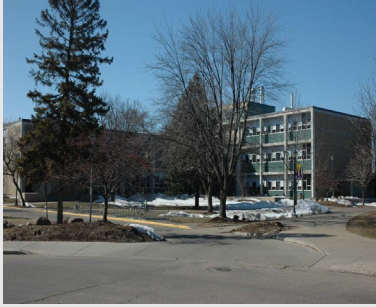
Building Name	Science Building

Building No.	285-0K-0006A						
Building Type	B02 Academic - Building						
Constructed	1972				AG	UG	
Addition(s)	1988			Floors	4	1	
ASF	47,253	GSF	85,044	GPR	100 %	PR	0 %
CENTRAL UTILITY CONNECTIONS				HISTORICAL			
CW	<input checked="" type="checkbox"/>	ELEC	<input checked="" type="checkbox"/>	C. AIR	<input type="checkbox"/>	US	<input type="checkbox"/>
HPS	<input checked="" type="checkbox"/>	FIBER	<input checked="" type="checkbox"/>	N. GAS	<input type="checkbox"/>	WI	<input type="checkbox"/>
D	FUNCTIONAL RATING				PHYSICAL RATING		iv
<small>Building Profile ratings based on the Postsecondary Education Facilities Inventory and Classification Manual (FICM): 2006 Edition</small>

Laboratory fume hoods require constant maintenance, built-in lab tables and sinks are old and unsightly. Fume hoods are for the most part at the standard height not allowing for ADA access.

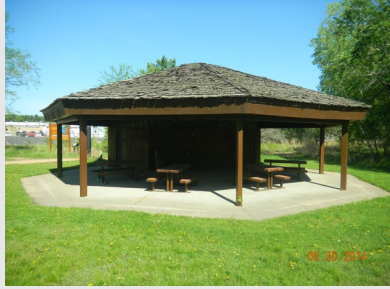
Building Name	Schmeeckle Reserve Shelter A

The shelter includes four picnic tables that are bolted to the cement floor, limiting the number of people that can use it. For large classes, many students must stand. The cedar shingles are aging and will need replacement.

Cedar shingles are aging and will need to be replaced soon.

Fixtures are outdated and inadequate for the amount of use.

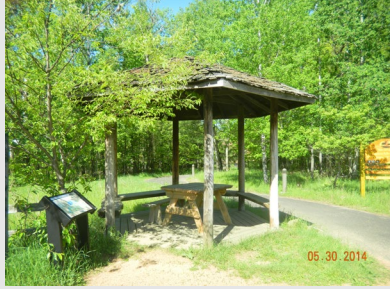
The cedar shingles on the roof are aging and will need replacement. Some of the decking boards will also need to be replaced.

Cedar shingles and decking are aging and will need to be replaced soon.

The picnic table will be removed and replaced with three standing interpretive signs. These will provide orientation to Schmeeckle Reserve, the Green Circle Trail, and the Wisconsin Conservation Hall of Fame. Cedar shingles and decking will be replaced.

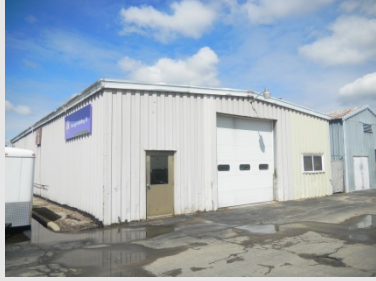
Roof and wall panel leaks. Metal wall panels are bowing on the south side. Skylights leak.

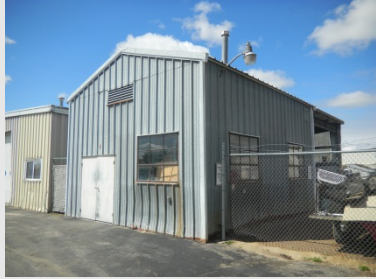
Metal roof and wall panels are showing signs of their age. A few windows are broken. Some wall panels have been damaged from vehicles.

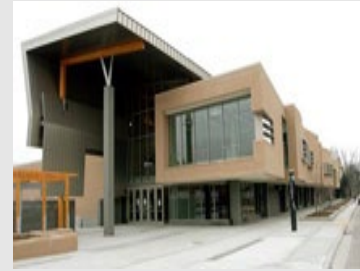
Building Name Lee Sherman Dreyfus University Center
Building No. 285-0K-0040
Building Type B07 Student Center/Union - Building

Northwest entrance has water ponding. Exterior food service door frames are rusting. Exterior concrete stairs are deteriorating. Occasional roof leaks. Laird Room flooring is outdated and deteriorating.

Systems are at acceptable levels. Campus users (not students) desire LCD projectors in meeting rooms. LCD projectors in large meeting rooms are old and require much maintenance and repair.

Two loading docks. Two passenger and two freight elevators. Main passenger elevator frequently breaks down. Freight elevators in acceptable condition.

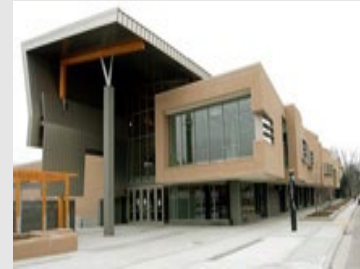
Building Name Lee Sherman Dreyfus University Center 1964 ADDN 1
Building No. 285-0K-0040A
Building Type B07 Student Center/Union - Building

Northwest entrance has water ponding. Exterior food service door frames are rusting. Exterior concrete stairs are deteriorating. Occasional roof leaks.

Systems are at acceptable levels. Campus users (not students) desire LCD projectors in meeting rooms. LCD projectors in large meeting rooms are old and require much maintenance and repair.

Two loading docks. Two passenger and two freight elevators. Main passenger elevator frequently breaks down. Freight elevators in acceptable condition.

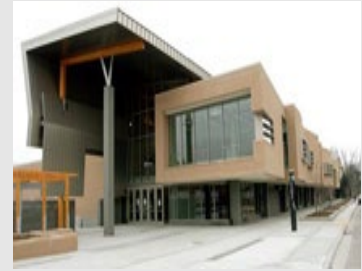
Building Name Lee Sherman Dreyfus University Center 2000 ADDN 3
Building No. 285-0K-0040C
Building Type B07 Student Center/Union - Building

Northwest entrance has water ponding. Exterior food service door frames are rusting. Exterior concrete stairs are deteriorating. Occasional roof leaks.

Systems are at acceptable levels. Campus users (not students) desire LCD projectors in meeting rooms. LCD projectors in large meeting rooms are old and require much maintenance and repair.

Two loading docks. Two passenger and two freight elevators. Main passenger elevator frequently breaks down. Freight elevators in acceptable condition.

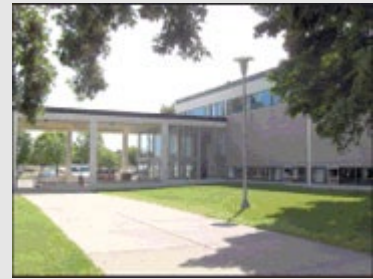
Building Name Allen Center
Building No. 285-0K-0041
Building Type B07 Student Center/Union – Building

Building envelope basically sound. Most windows leak and are not energy efficient. Roof will need repair or possible replacement within three years.

Building mechanical system controls in the basement are in deteriorating condition. Steam reducing valve system occasionally fails. Exterior doors do not close completely because of air pressure issues. Concerns with air quality.

Building cabling and wiring, equipment (fire alarm, normal power), lighting, panels are all in good condition. Automatic transfer switch for emergency generator is old and failing. Must duck under HVAC ductwork to access some electrical equipment.

Communication equipment (clocks, data, security and voice), panels and wiring are all in good condition. Surveillance cameras provide poor resolution.

Building plumbing equipment (domestic water, fire protection and suppression, sanitary sewer, storm sewer), fixtures, insulation, and piping are all in good condition. Current hot water storage tank is outdated.

One passenger elevator is 24 years old and is on 10 Year Maintenance Replacement plan.

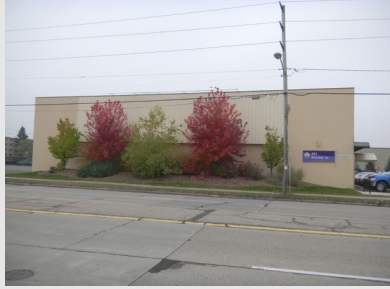
Building Name	601 Division Street Building

CMU is spalling on southwest corner

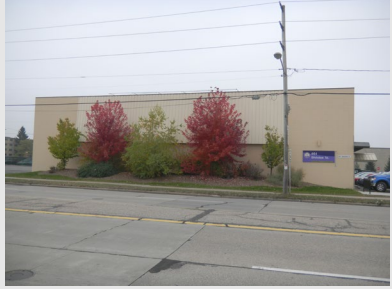
Building Name	601 Division St Building 1974 Addition 1

CMU is spalling on southwest corner

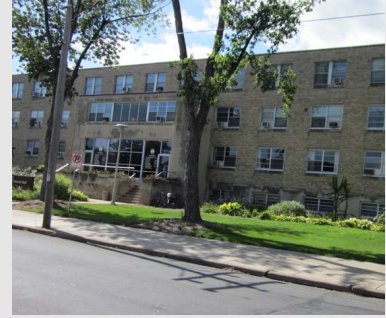
The building is structurally sound but its systems are antiquated and in desperate need of capital renewal. A high probability that a future building system failure will force a building shut-down and rendered it unoccupiable. Building systems and space configurations, in general, are not adequate for the activities housed there. If the building is to continue in service, the building systems must at a minimum be updated and the spaces renovated.

Leaks occur between the second floor and third floor addition.

Constant glazing leaks/issues. All single pane glazing needs replacing due to constant leaks. No direct ADA access to any level. All levels must be accessed by an elevator.

Original steam convection & distribution pipes (condensate pipe walls thinned / deteriorated beyond suitable repair), no ventilation, no modulating heat controls (manual heat valves, one pneumatic t-stat controls entire building). Cooling accomplished by inefficient window air conditioning units and multiple direct expansion units throughout building. Systems are in very poor condition.

No emergency power No back-up generation to operate fans/actuation-outages in winter could result in freeze-up due to inability to circulate steam heat. Electrical service and distribution panelboard, undersized and in poor condition.

Overall condition is poor. Several sanitary and storm sewer cross connections have been noted. Fixtures in poor condition, many inoperable. Entire Piping system very poor, Water tests indicate high/unsafe levels of lead and phosphates when adequate volume is not circulated through system. Controls for domestic hot water heater have failed repeatedly, parts are no longer available.

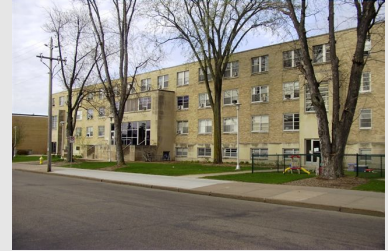
Building Name Delzell Hall 1956 3rd Floor Addition 1
Building No. 285-OK-0061A
Building Type B01 Administrative - Building

Water infiltration between 2nd floor and 3rd floor addition

Mostly original perimeter convectors, no ventilation beyond basement or 1st floor no thermostats. Poor to very poor condition.

No emergency power
 Electrical service, poor condition, poor location

Most fixtures in poor condition, many inoperable
 Piping system very poor

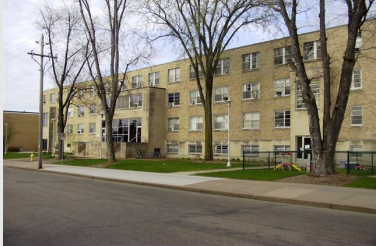
Building Name	Delzell Hall Elevator Addition 2

Water infiltration between 2nd floor and 3rd floor addition

Mostly original perimeter convectors, no ventilation beyond basement or 1st floor no thermostats. Poor to very poor condition.

No emergency power
Electrical service, poor condition, poor location

Most fixtures in poor condition, many inoperable
Piping system very poor

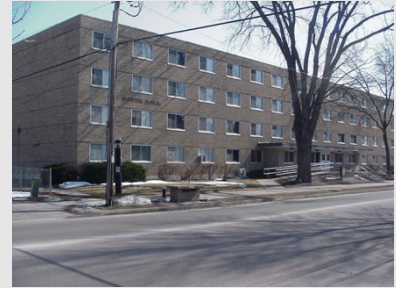
The windows are original aluminum 4-pane system with limited weather stripping and are very energy inefficient. There is some water leaking.

Pipes are corroding.

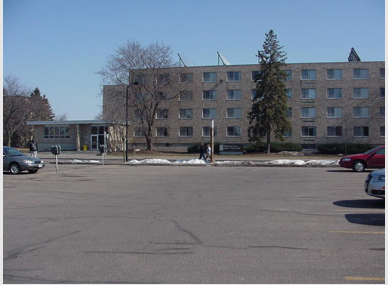
Building Name	Pray-Sims Hall (Original Pray)

The windows are the original aluminum 4-pane system with limited weather stripping are very energy inefficient. There is some water leaking.

Pipes are corroding.

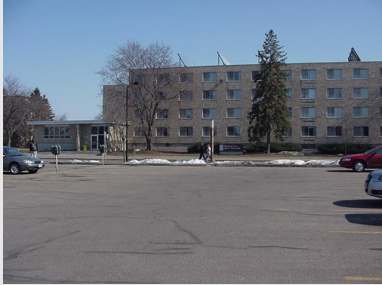
Building Name	Pray-Sims (Original Sims)

Pipes are corroding.

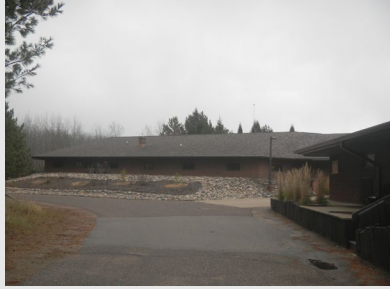
Exterior caulking is deteriorating and the exterior should be painted.

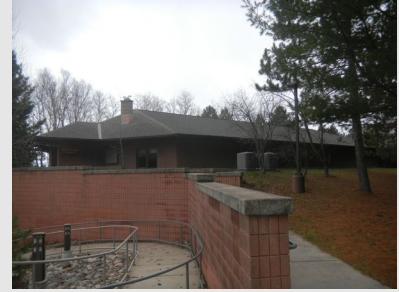
Exterior caulking is deteriorating and the exterior should be painted.

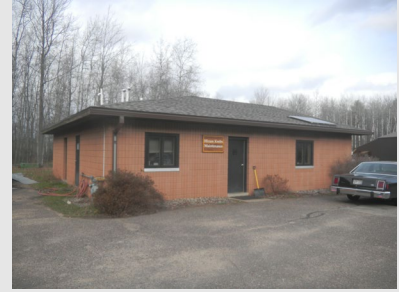
Exterior painting is failing.

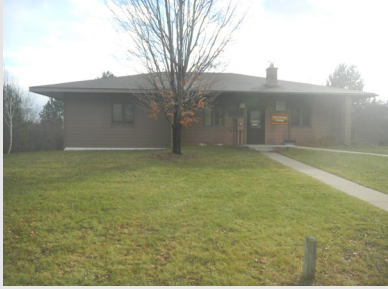
Building Name	Treehaven Fern Young Cottage

Exterior paint is failing. Exterior deck and railing are deteriorating and should be replaced.

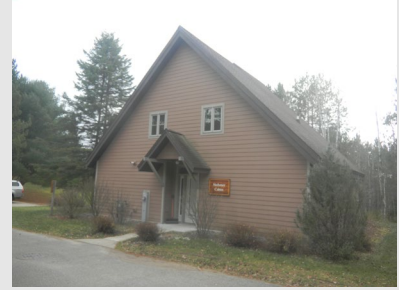
Some roof leaking issues.

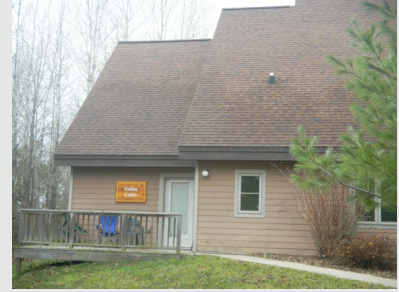
Some roof leaking issues.

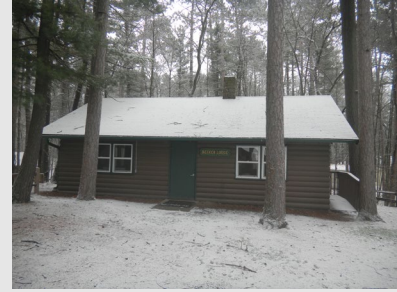
Windows replaced in 2013. No insulation.

No emergency power. Electric baseboard heat replaced wood stove.

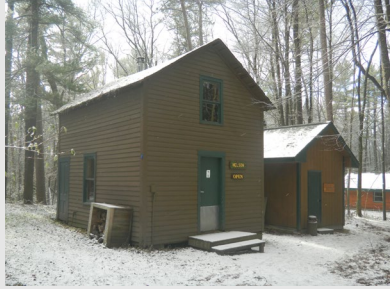
Interior finishes are deteriorating. Little insulation.

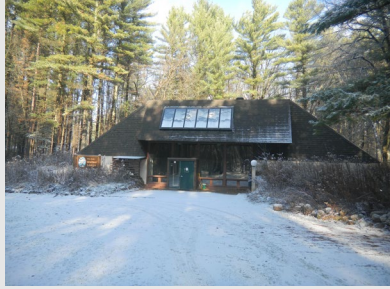
Conditional – some improvements are necessary for program support.

Building is ADA accessible. Some mold concerns due to moisture in building.

Roof leaks evident in bathrooms. Shingles fall off on front roof. Carpet is difficult to maintain and is replaced frequently. Passive solar system was repaired and is now operating.

Gas furnace provides heat but is old and unreliable. Air-conditioning is provided but with no fresh air.

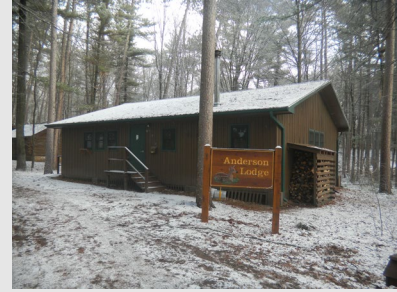
Little insulation. Windows replaced.

Heat is provided by a wood burning stove.

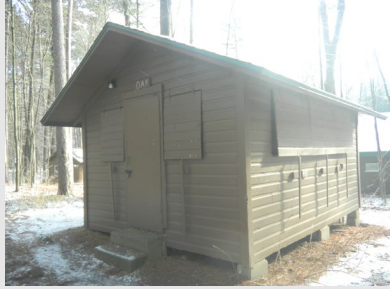
D	FUNCTIONAL RATING	PHYSICAL RATING	iv
----------	--------------------------	------------------------	-----------

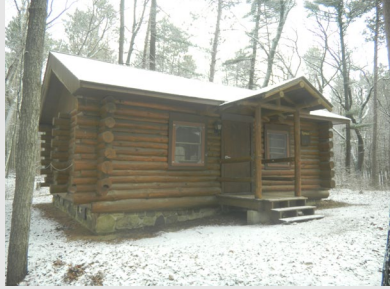
C	FUNCTIONAL RATING	PHYSICAL RATING	iii
----------	--------------------------	------------------------	------------

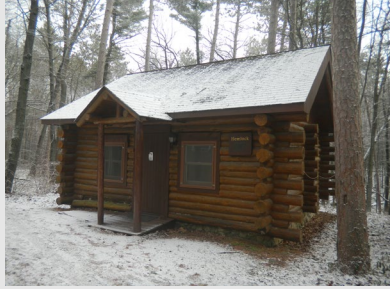
C	FUNCTIONAL RATING	PHYSICAL RATING	iii
----------	--------------------------	------------------------	------------

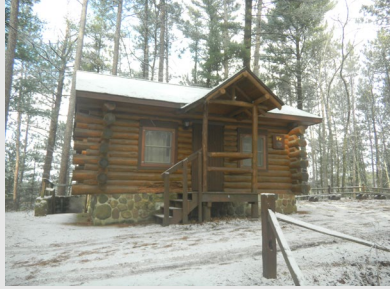
C	FUNCTIONAL RATING	PHYSICAL RATING	iii
----------	--------------------------	------------------------	------------

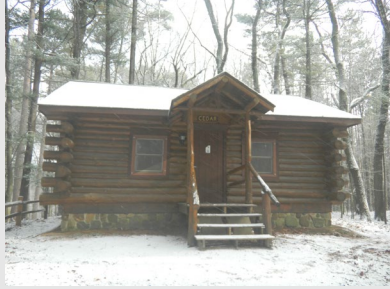
C	FUNCTIONAL RATING		PHYSICAL RATING	iii
----------	--------------------------	--	------------------------	------------

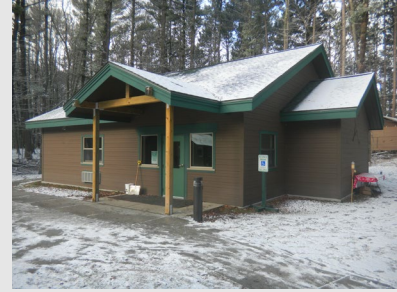
A	FUNCTIONAL RATING	PHYSICAL RATING	i
<small>Building Profile ratings based on the Postsecondary Education Facilities Inventory and Classification Manual (FICM): 2006 Edition</small>

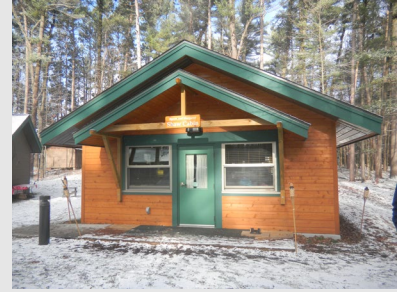
A	FUNCTIONAL RATING	PHYSICAL RATING	i
<i>Building Profile ratings based on the Postsecondary Education Facilities Inventory and Classification Manual (FICM): 2006 Edition</i>

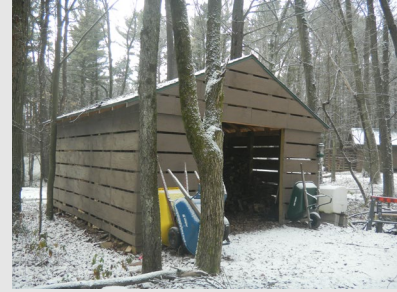
A	FUNCTIONAL RATING	PHYSICAL RATING	i
<small>Building Profile ratings based on the Postsecondary Education Facilities Inventory and Classification Manual (FICM): 2006 Edition</small>
