Shoreland Assessment of Shell Lake

Washburn County, Wisconsin

December 2013

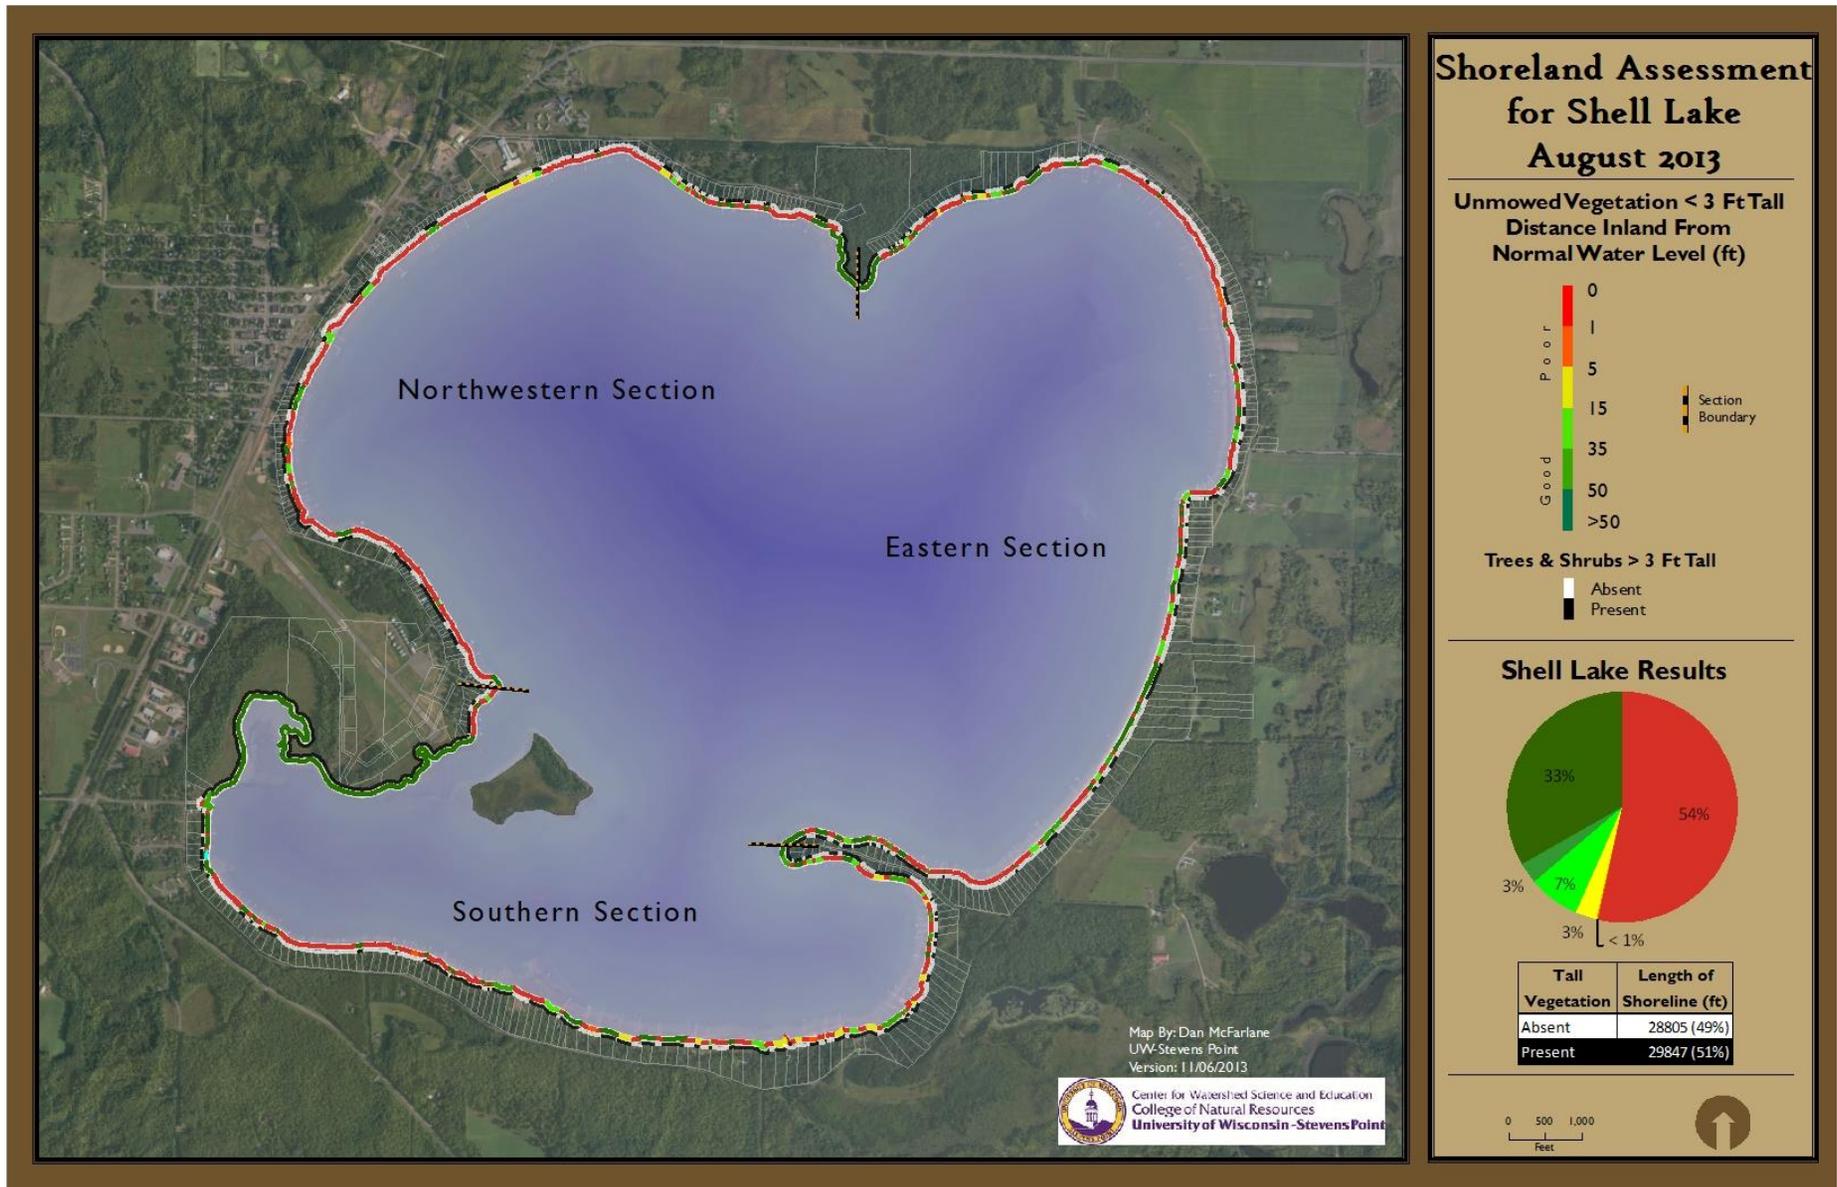
Figure 2: Distance of unmowed vegetation (< 3 feet high) inland from normal water level around the Shell Lake shoreland.

The vegetation categories used for the shoreland vegetation survey above the normal water level were: wetlands, organic, barren, new shoreland restoration, mowed vegetation, and short unmowed vegetation less than 3 feet in height (Figure 2). Wetlands were assigned to areas that supported aquatic or water-loving vegetation on the shore. Wetlands provide habitat that supports a wide variety of plant and animal species, and play an important role in the life cycles of fish, amphibians, birds, and mammals, while helping to slow runoff and diffuse wave energy. The "organic" category was assigned to shoreland areas that were predominantly covered by pine needles or leaf litter, which can act like a sponge and slow runoff. Barren land can contribute sediments and nutrients to the lake. The additions can result in the additional growth of algae and aquatic plants and may plug up gravel that would be used by spawning fish. New shoreland restoration is characterized by shorelines being restored back to their natural state. No shoreland restorations were observed during this survey. Mowed vegetation was assigned to shorelands that were mowed all the way to the normal water level. In a shoreland, with the exception of an access path, mowed vegetation is not desirable because it provides little habitat and minimal filtration of runoff. Impervious surfaces included areas where water could not infiltrate into the ground, allowing runoff and pollutants to quickly enter the lake and do not provide habitat. Rooftops, stairways, boat landings, structures are examples of impervious surfaces. To better understand the results of the surveys, we will discuss the lake as a whole, and as three sections, the northwestern, eastern, and southern lobes (Figure 2). Thirty-six percent of Shell Lake's shoreline had good shoreland vegetation, with the "vegetative buffers" extending at least 35 feet inland from the normal high water. The southern section had the greatest extent of healthy shoreland. Ten percent of the shoreland had some vegetation in place (inland 5 -35 feet), and the majority of the shoreline (54%) lacked any vegetative buffer (Table 1).

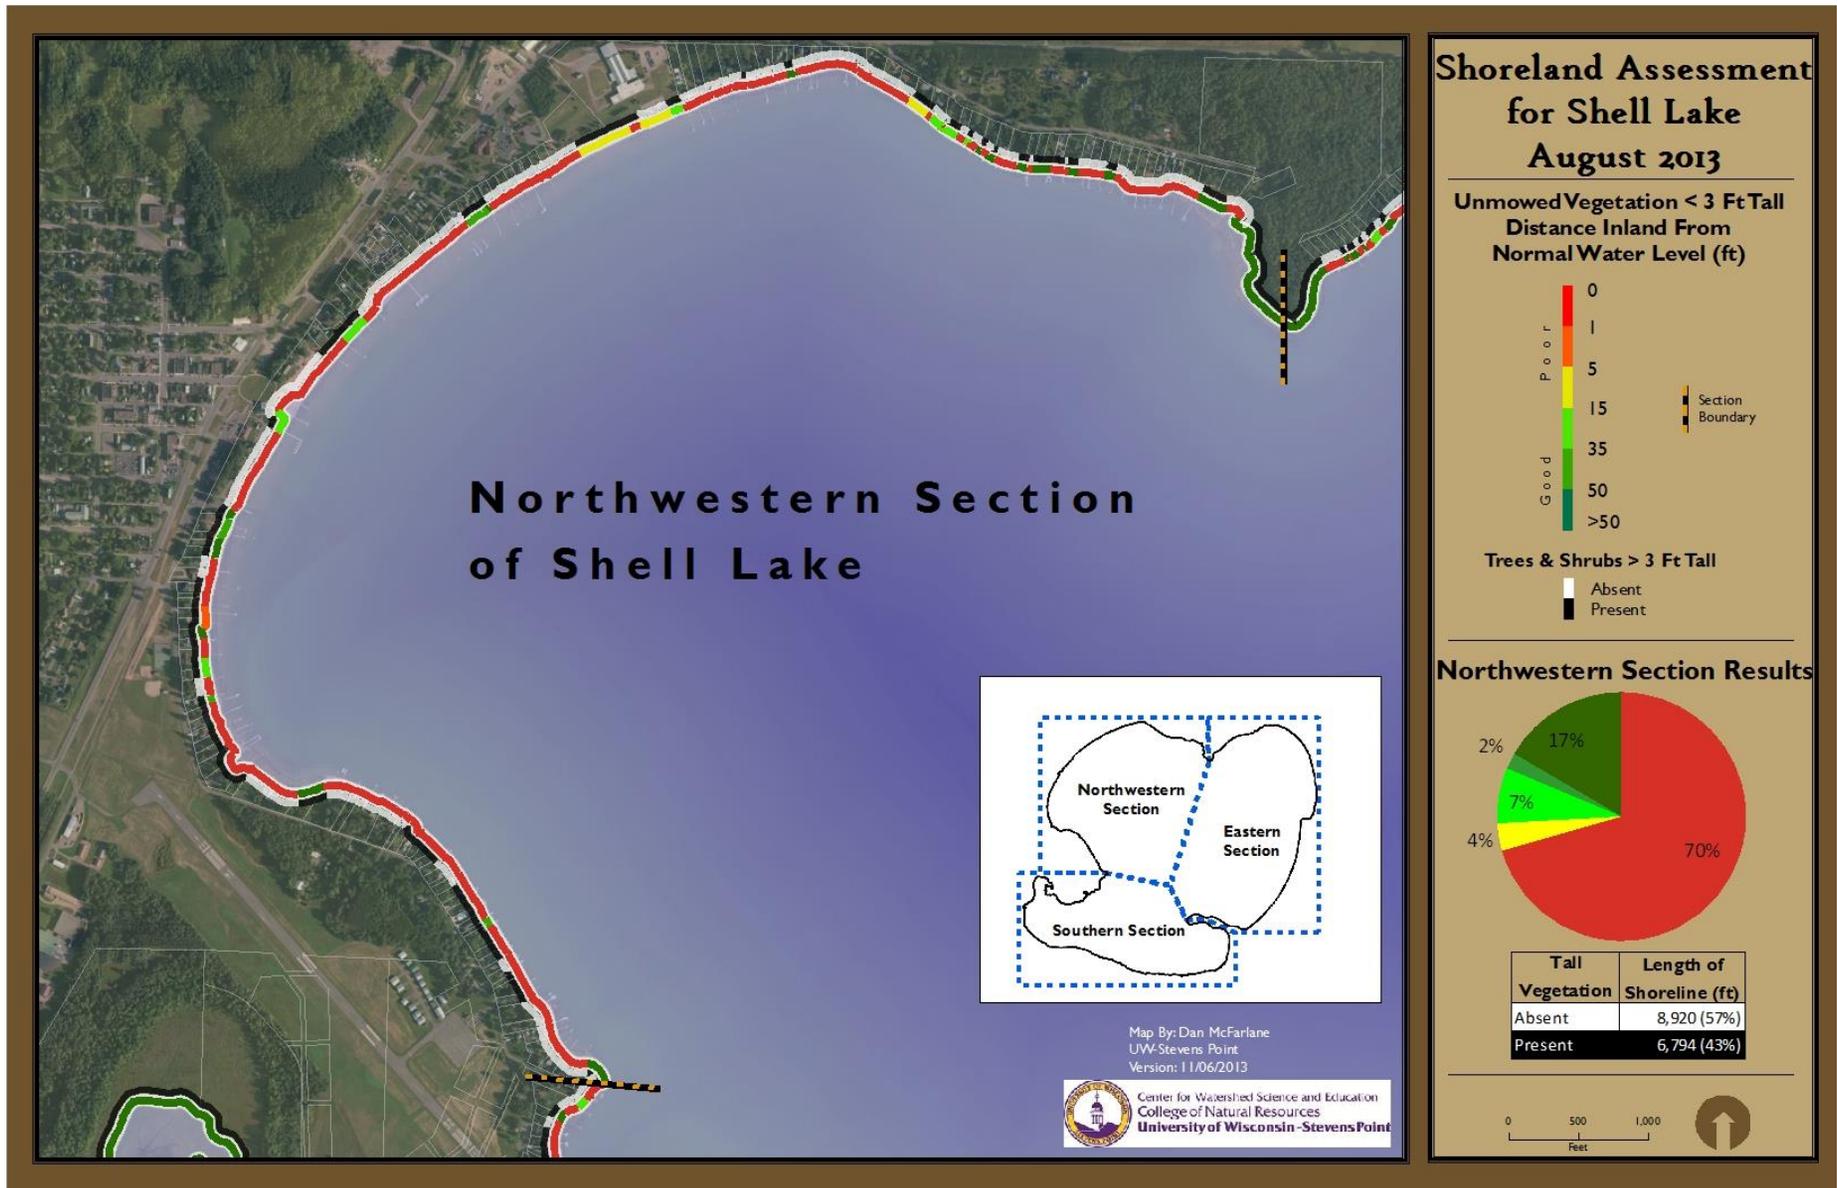
Figure 3: Distance of unmulched vegetation (< 3 feet high) inland from normal water level around the Shell Lake shoreland for the northwestern section, 2013.

The northwestern section of Shell Lake includes the campgrounds and swimming areas. Given that this is an area of high activity, it is susceptible to erosion which may lead to an increase of sediments and pollutants flowing into Shell Lake during storms and snow melt. Seventeen percent of the northwestern section had vegetative buffers of 35 feet or more inland from the normal water level. Most of this land was located on the peninsula in the northern portion of this section, at the section boundary on the map in Figure 3. Additional shoreland in this category was scattered intermittently throughout this section. Eleven percent of this section had unmowed vegetation that ranged from 5 to 35 feet inland. These areas, although in small amounts, can be easily improved by ceasing mowing or through restorative efforts. Unfortunately, the majority of this section lacked vegetative buffers for 70% of its length (Figure 3). A large volume of sand occupies the shoreline in this section, making it very susceptible to erosion and increased sediment supply to Shell Lake. Forty-three percent of the shoreland in this section had shrubs/trees present.

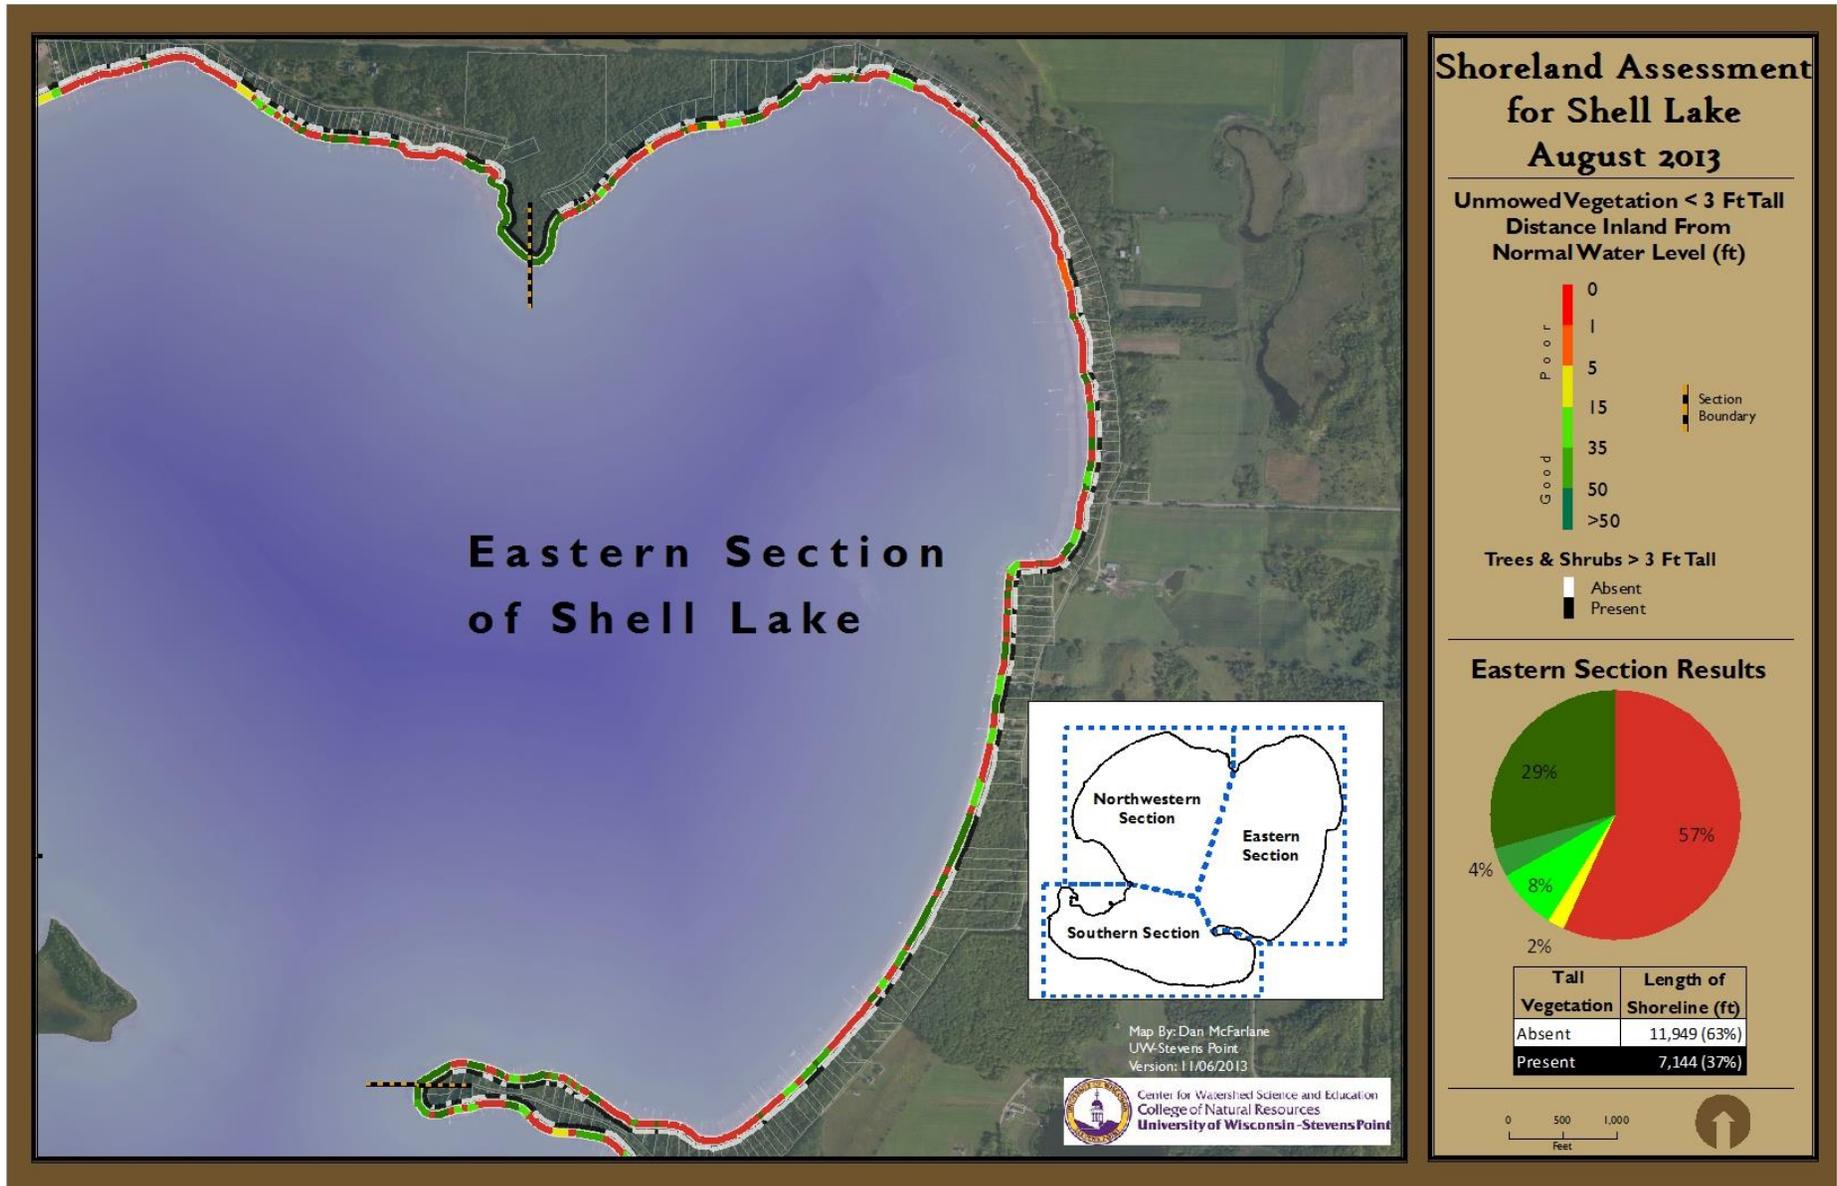
Figure 4: Distance of unmowed vegetation (< 3 feet high) inland from normal water level around the Shell Lake shoreland 2013 for the eastern section.

The eastern section had unmowed shoreland vegetation more than 35 feet inland from the normal water level for 33% of its length. Vegetation ranging from 5 to 35 feet inland occupied 10% of the eastern section's shoreline. If improvements were made to increase the extent of unmowed vegetation to a depth of 35 feet or greater inland, 43% of its shoreline would be in good condition. Unfortunately, 57% of the shoreline in the eastern section lacked unmowed vegetation (Figure 4). Shrubs/trees were present on 37% of the shoreline in the eastern section of Shell Lake.

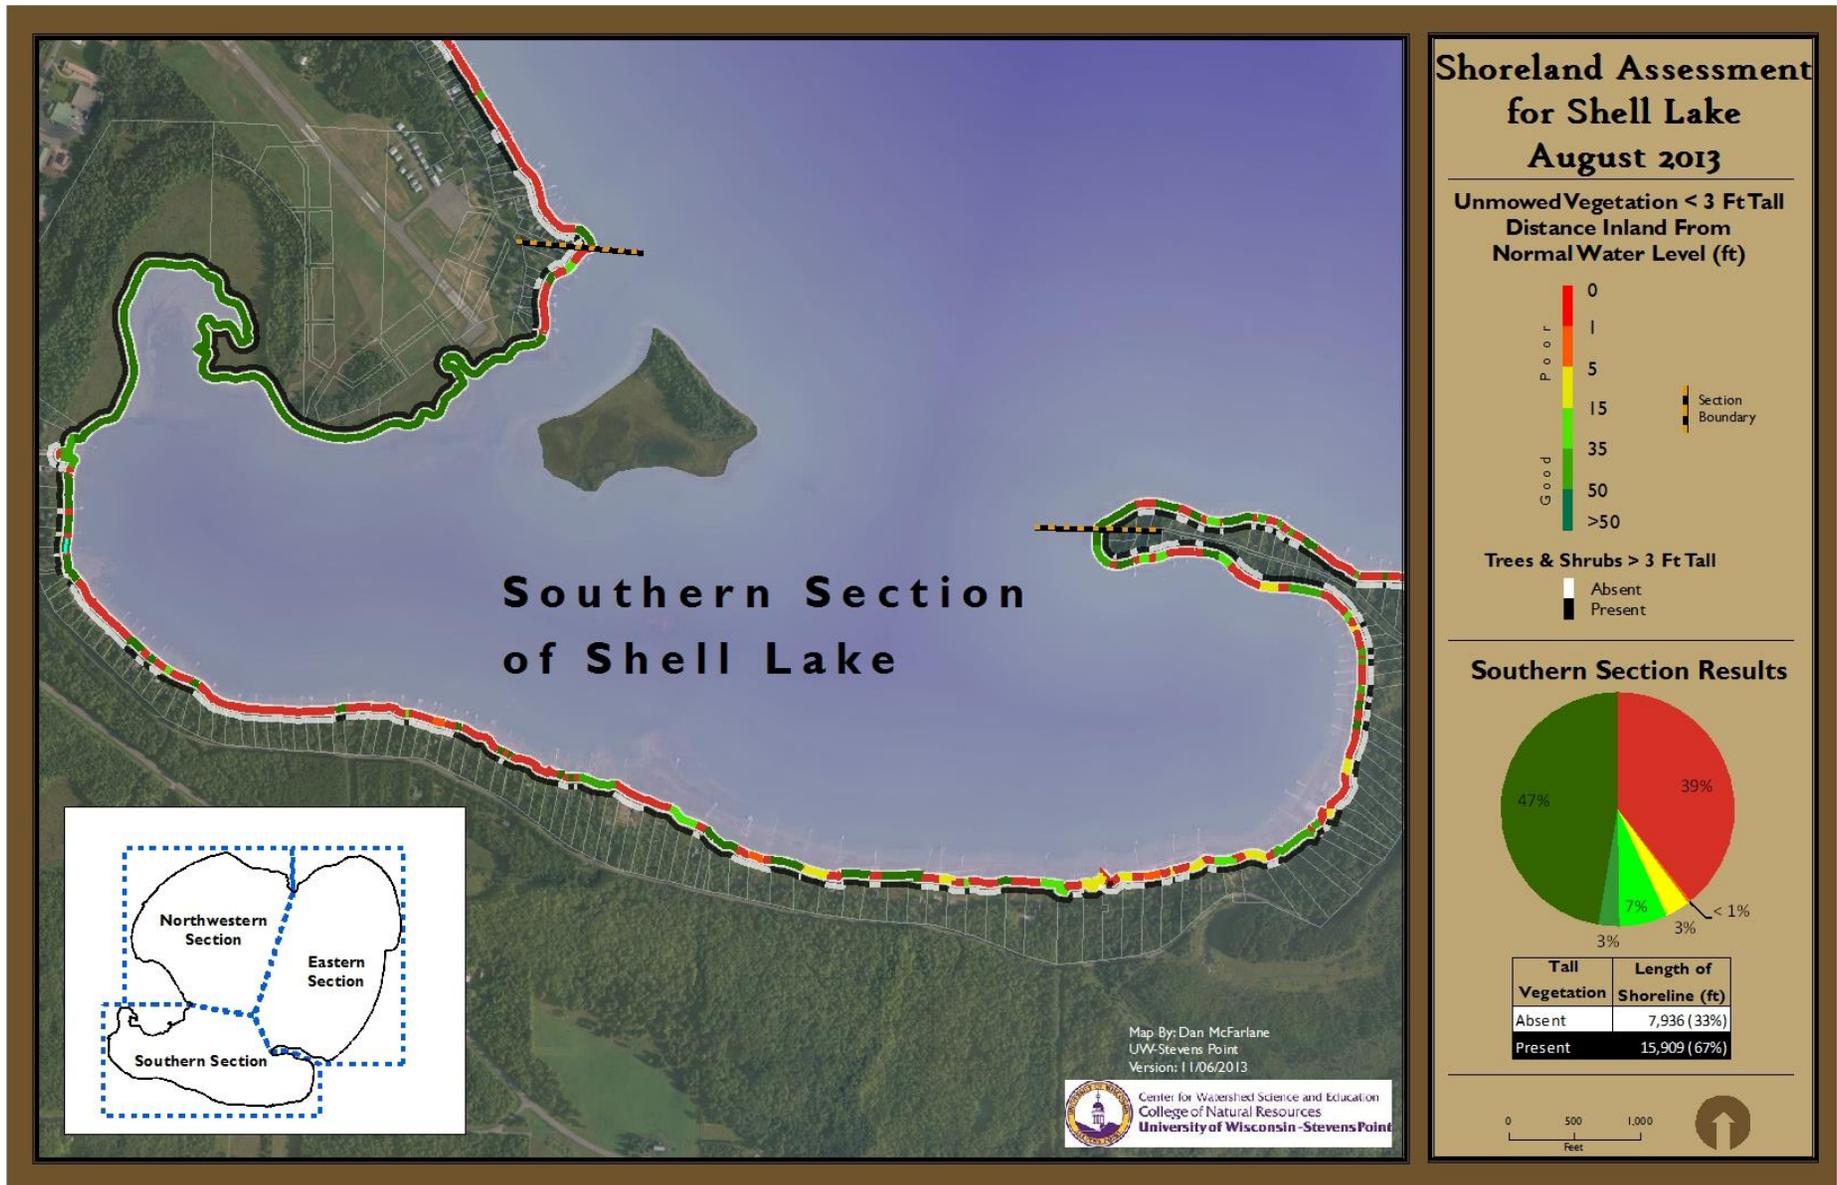
Figure 5: Distance of unmowed vegetation (< 3 feet high) inland from normal water level around the Shell Lake shoreland 2013 for the southern section.

Fifty percent of the southern section's shoreline had unmowed vegetation that extended 35 or more feet inland from the normal water level. The majority of this length occurred in publically-owned land. In addition, there were scattered parcels with shoreline exhibiting high quality buffers. Unmowed vegetation ranging between 5 and 35 feet inland comprised 10% of the shoreline in this section. Thirty-nine percent of the shoreline in the southern section of Shell Lake was mowed to the water's edge (Figure 5). Sixty-seven percent of the shoreline in the southern section of Shell Lake had shrubs/trees.

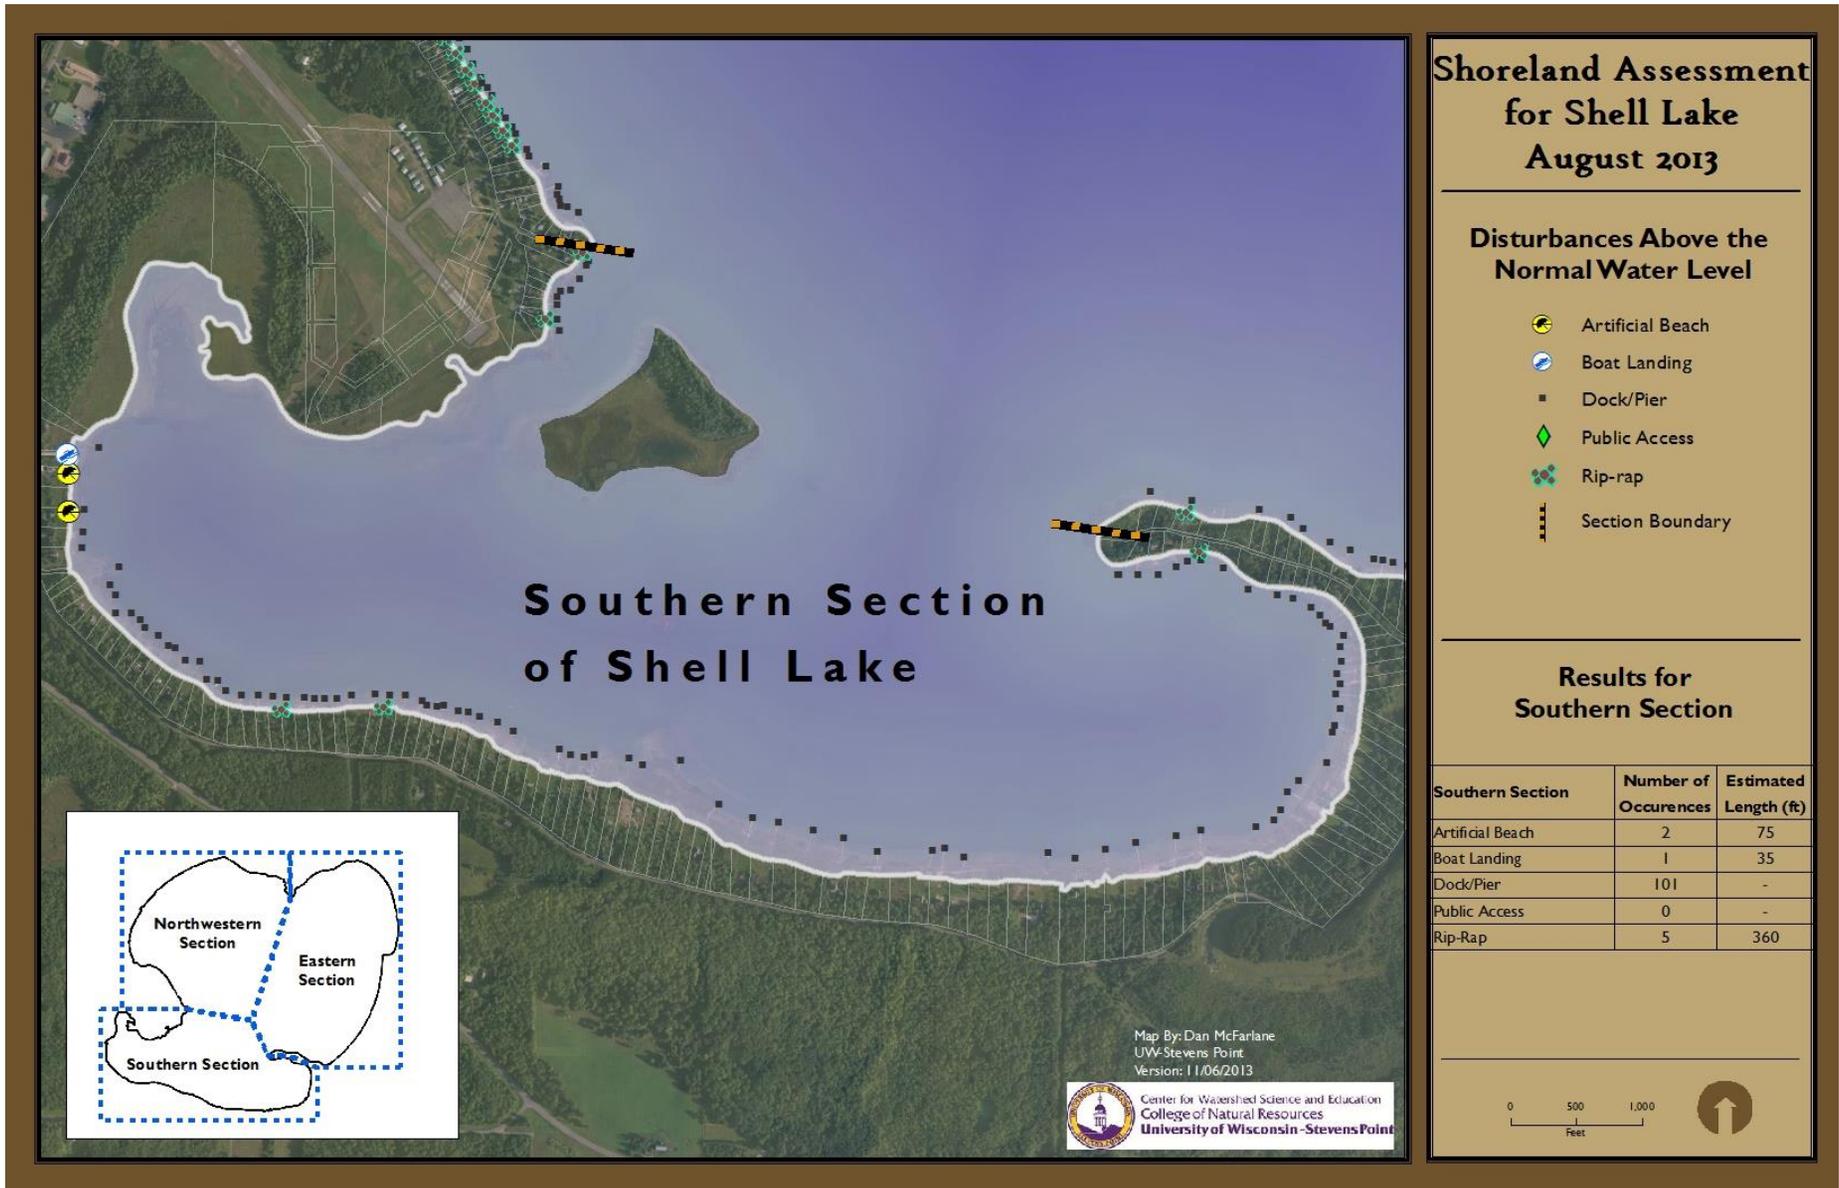
Figure 9: Near shore disturbances above the normal water level in Shell Lake for the southern section, 2013.

A large percentage of the southern section's shoreline is owned and managed by the Wisconsin Department of Natural Resources. At present, no shoreland disturbance existed along this stretch of shoreline. There were two occurrences of artificial beaches in this section with a total estimated length of 75 feet (Figure 9). Artificial beaches are most exposed and do not contain vegetative buffers. They are therefore the areas of shoreline that are most susceptible to erosion and contribute the most sediment into the lake. Ideally, a minimal number of locations of artificial beaches should be present on a lake's shoreline, enough to provide opportunities for beach-lovers that are looking for a stretch of sand. Five locations had rip-rap in the southern section, which occupied an estimated length of 360 feet of shoreline. Whenever possible rip-rap should be removed and replaced with properly engineered shorelines where native shoreland vegetation can be reestablished.

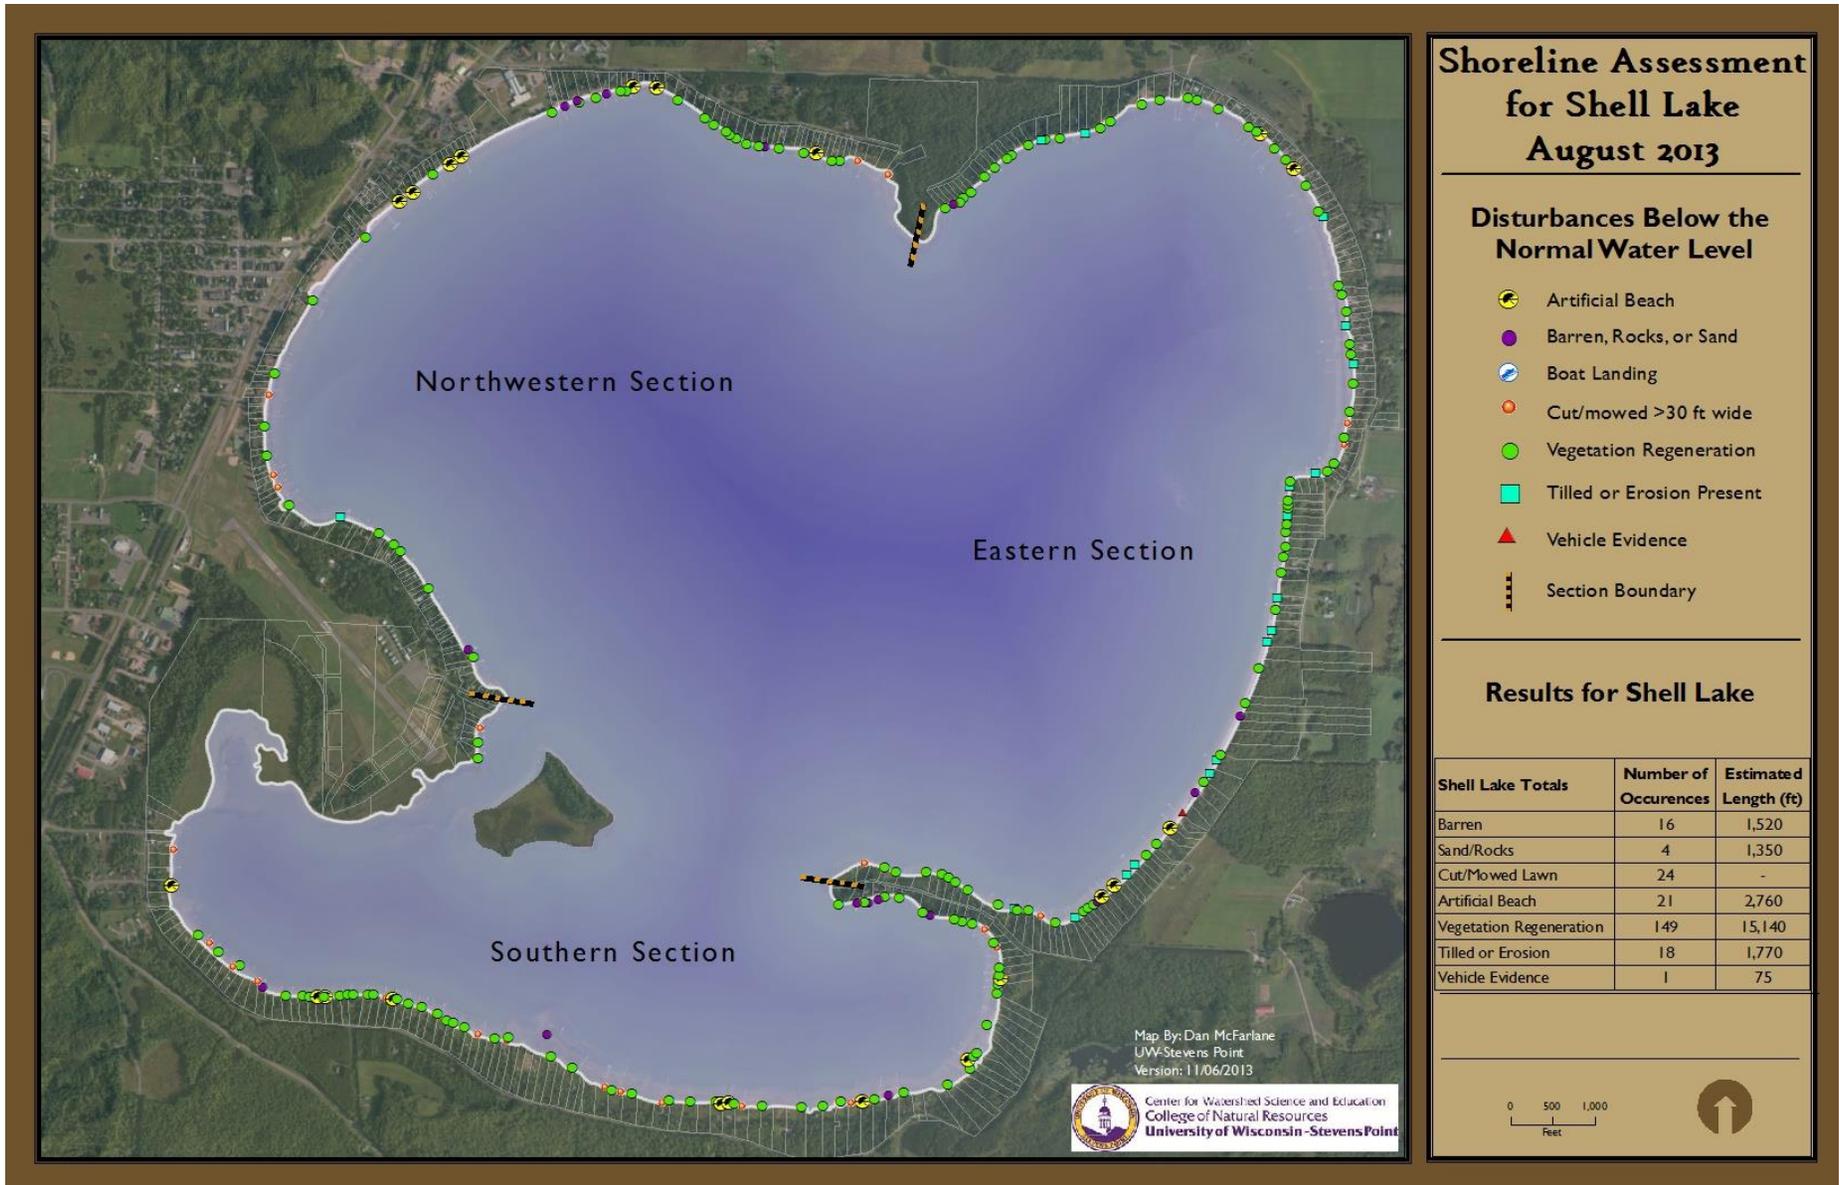
The northwestern section had a significant amount of vegetation regeneration occupying its shoreline. There were 29 total restoration occurrences with an estimated length of 3,350 feet. As these locations continue to resemble the shoreline's natural state they will provide suitable habitat for fish and other wildlife when lake levels increase. Sand and rock comprised two which accounted for 1,200 feet of the shoreline. There were seven occurrences of artificial beaches with an estimated length of 1,550 feet of shoreline (Figure 11).
